Inspection Report

ASAP Home Inspections LLC

10555 Sample Drive Truckee, CA 96161

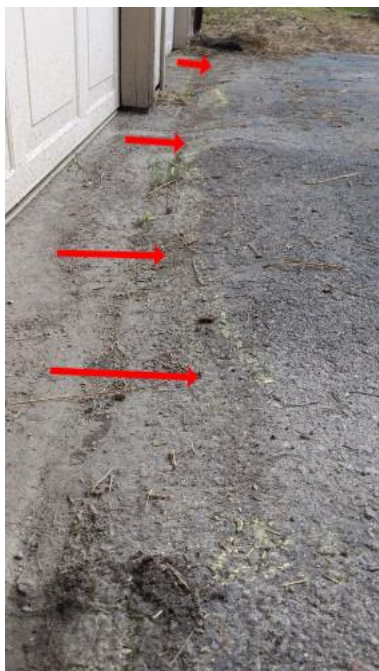
(Safety) Tripping hazards were observed. A 2" rise from garage to driveway was observed. These should be repaired for safety.

Bulge in the driveway by the garage

Recommend a qualified professional evaluate and repair or replace as needed.

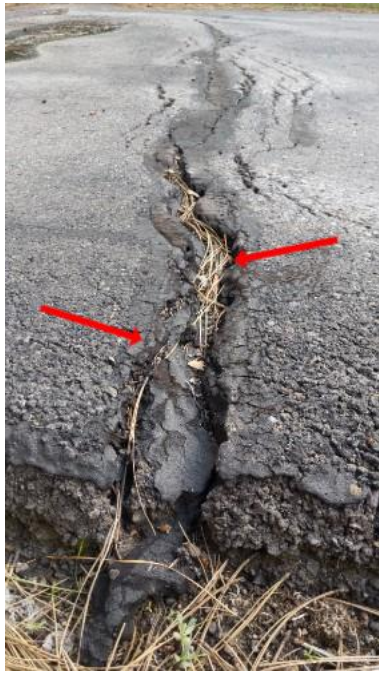
(Repair) Common cracks, major cracks and settlement were observed in the driveway making it an uneven surface. The major crack was 2" wide at the widest point. The driveway shows evidence of ponding. The driveway should be sloped to allow for proper drainage.

Large crack on side of driveway

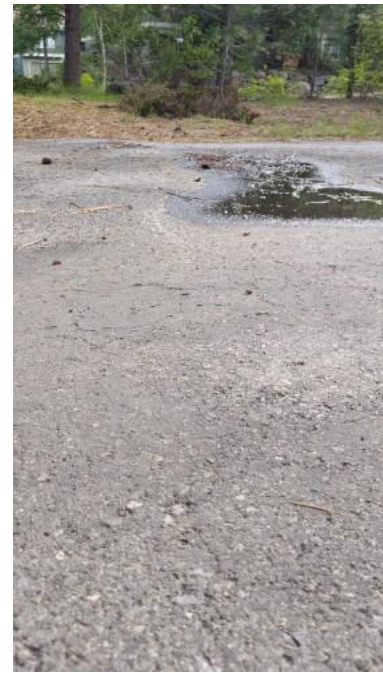
Ground angle of the ponding noting the driveway height differences

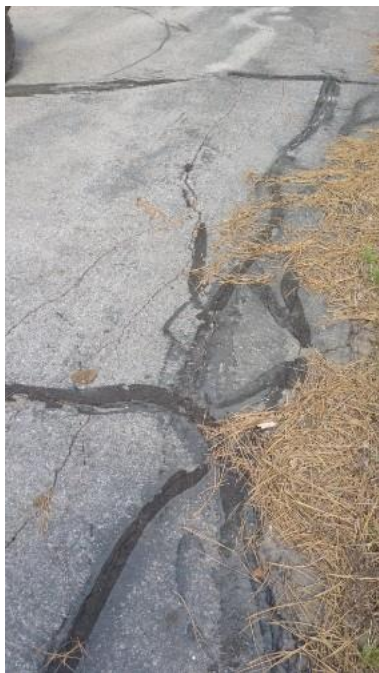
Smaller cracks that were properly sealed

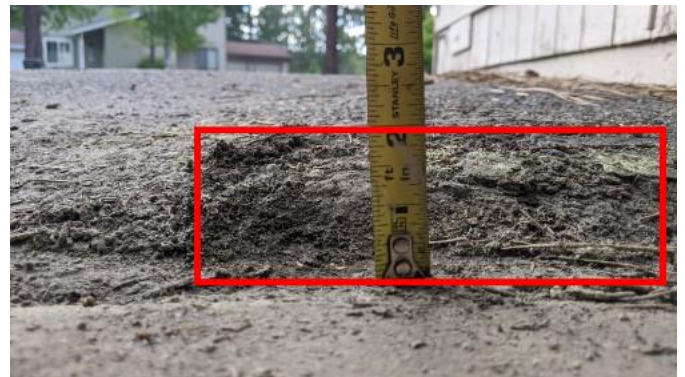
Trip hazard on the corner of the driveway and garage.

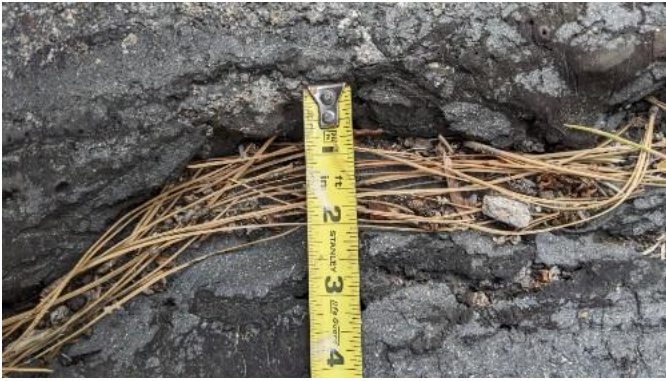
2" gap measured in the crack on side of driveway

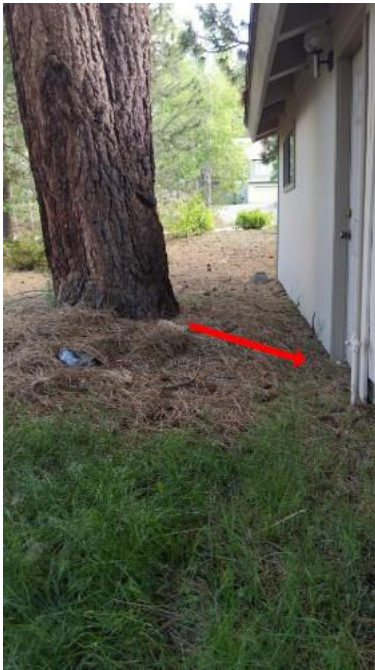
The grading slopes towards the South and East side of home/garage. The East side has a garage access door. This can allow water penetration. Recommend qualified professional evaluate and repair.

Slopes towards garage access door and East side of home.

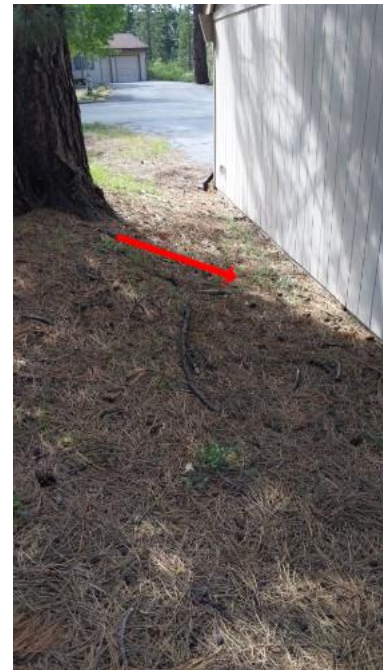
Slopes towards South side of the home/garage.

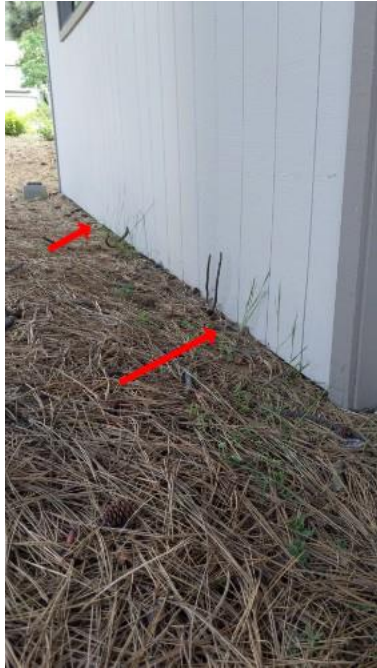
East side of home

6-8" of ground clearance recommended. Earth/soil is in contact with wood siding which allows deterioration and moisture penetration. Recommend the wood siding be at least 6" from Earth/soil/ground.

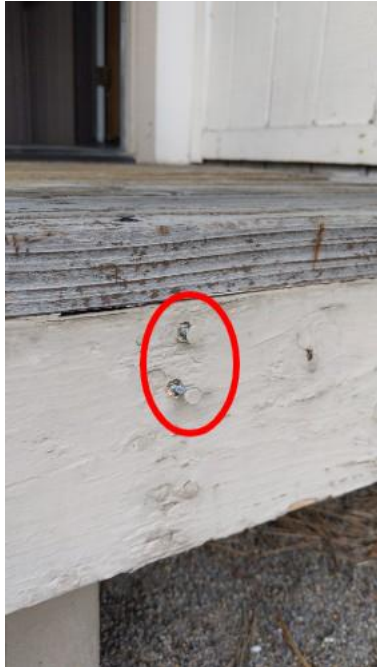
Exposed nails, paint chipping and deterioration were observed on the front entrance deck. Scuffs and deterioration on the bottom of the front door was observed. The front entrance light was not operating at the time of inspection. The top of the deck railing was loose at the time of inspection.

Nails exposed

It is suggested that a "Licensed General Contractor" be contacted for further evaluation and repair.

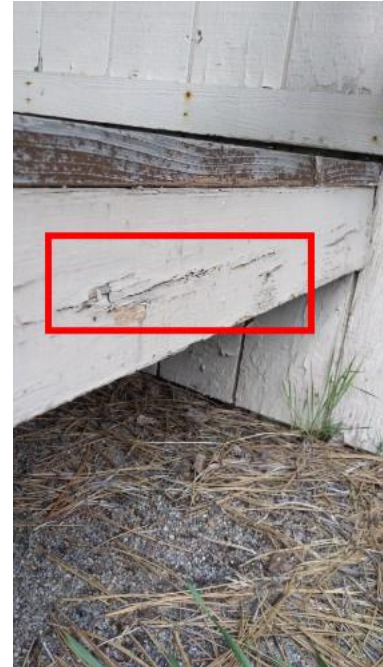
Paint chipping and deterioration

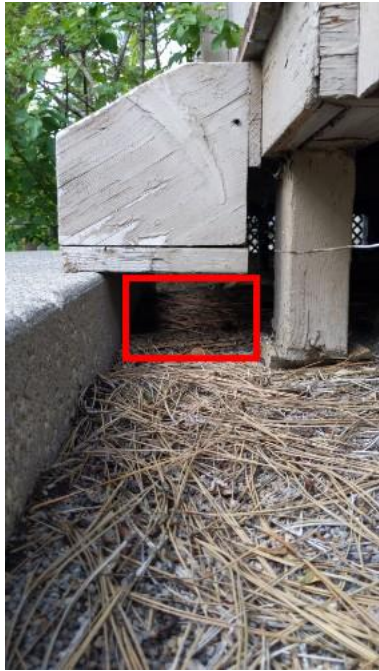
The front step was improperly constructed. The step is resting on the concrete landing with no other support or fastening.

Improper construction

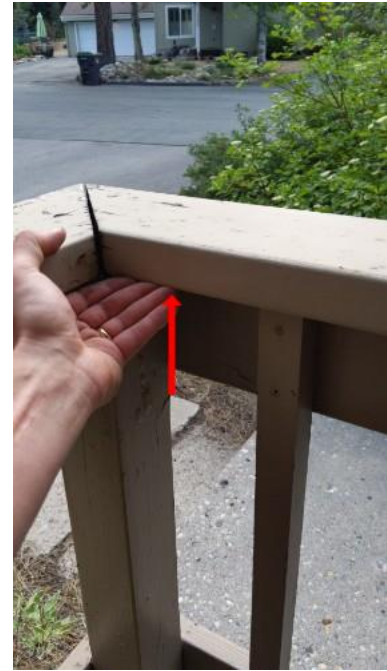
The top part of the railing is loose

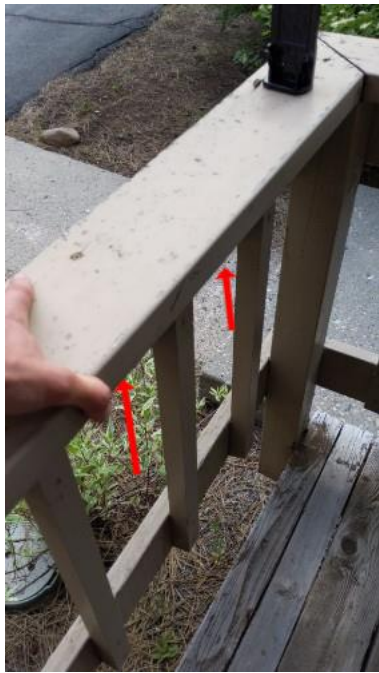
The top part of the railing is loose

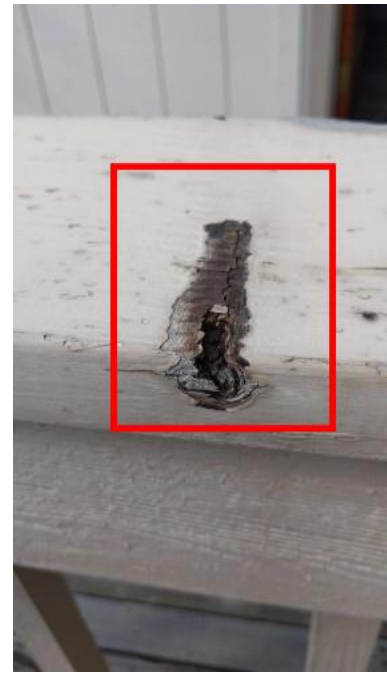
Deterioration on railing

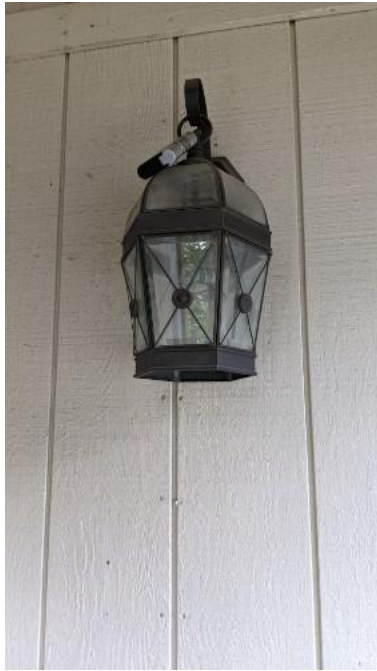
Front entrance light not operating

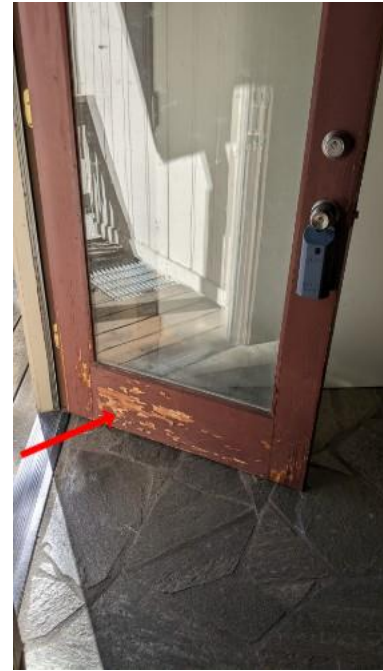
Scuffs and deterioration on front door

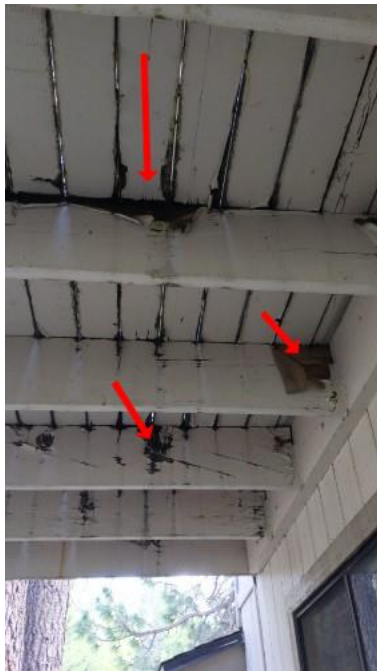
Paint peeling and deterioration under the deck

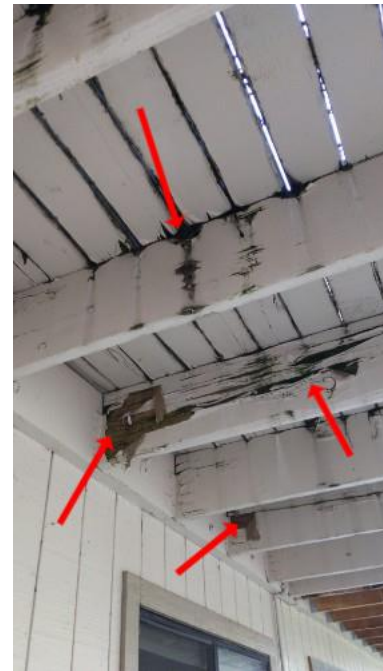
Paint peeling and deterioration under the deck

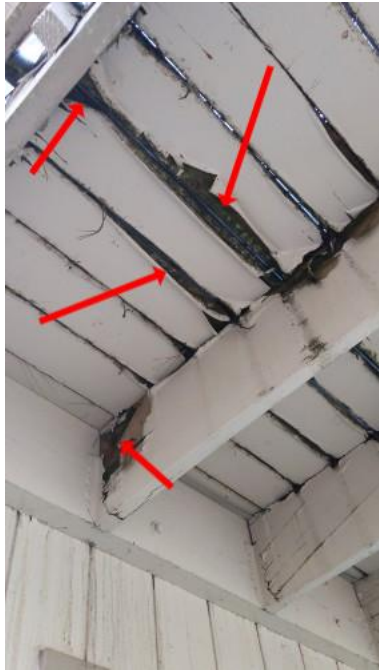
Paint peeling and deterioration under the deck

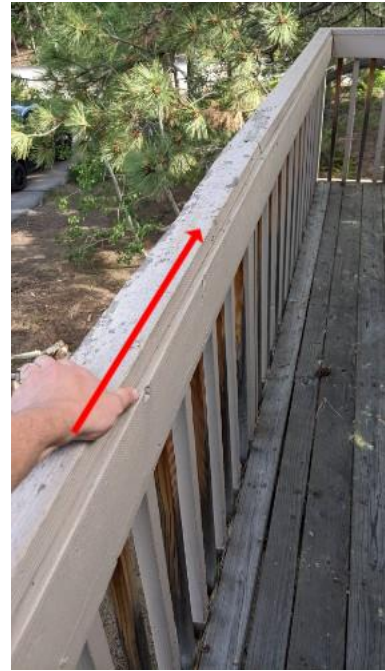
(Safety)The back deck railing (East) was loose at the time of inspection. This is a safety hazard. Multiple exposed nails raised above 1/4" were observed throughout the deck. These are a tripping hazard. It is suggested that a "Licensed General Contractor" be contacted for further evaluation and repair.

Back deck railing was loose

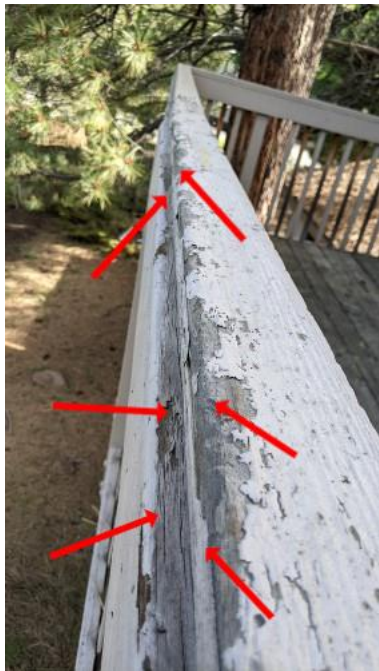
Paint peeling and deterioration on deck railing

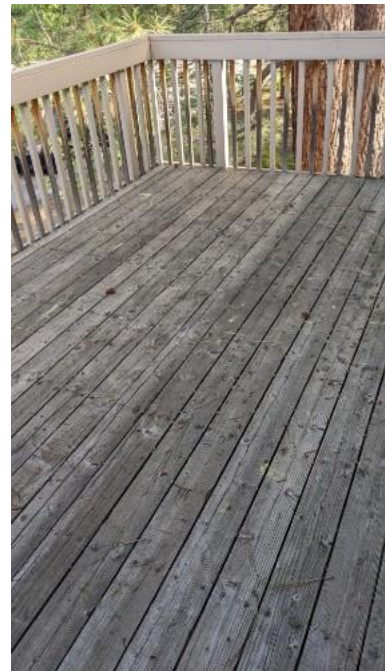
Deck surface weathered

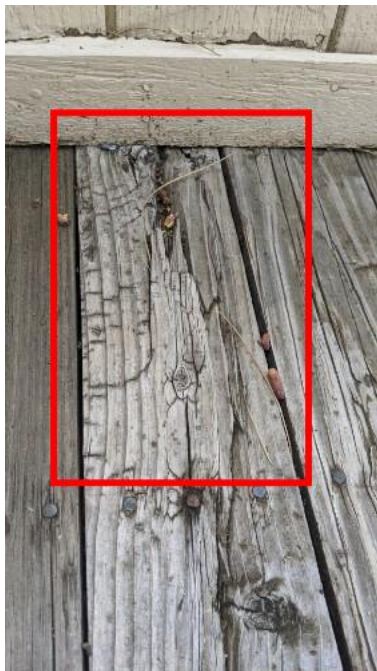
Weathered deck board cracking

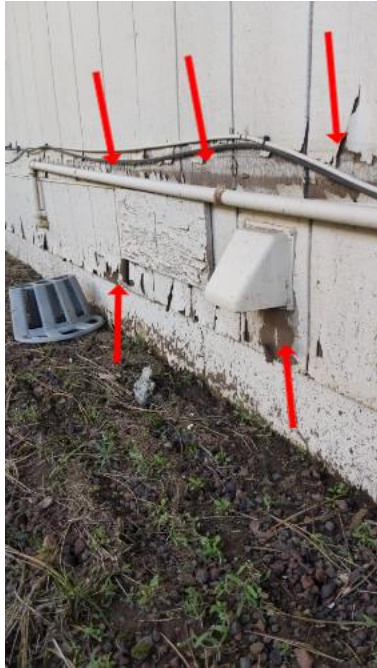
Paint peeling and deterioration on East side of home

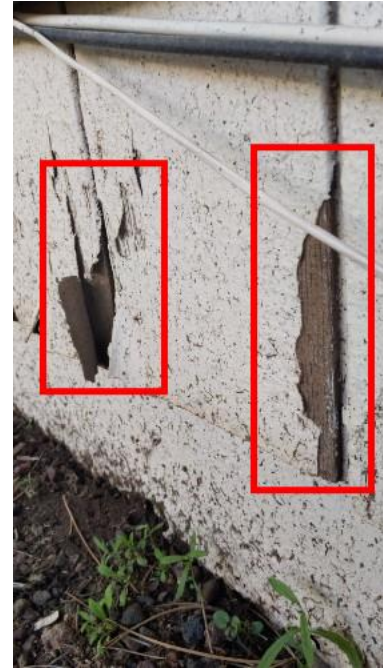
Paint peeling and deterioration exposed wood siding

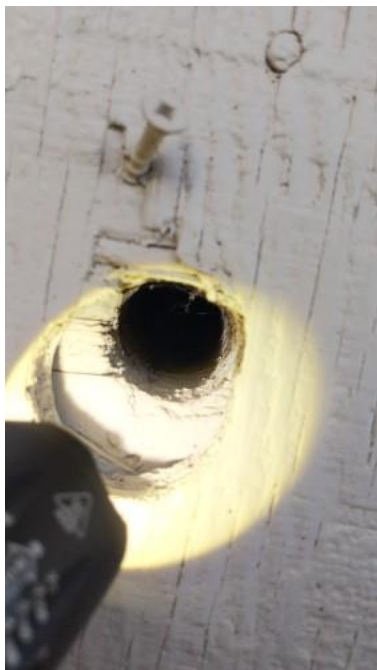
An exposed hole was observed on the East side of the home. This can allow moisture and pests to enter. Wood deterioration on the end of the wood beam on the South side of the home was observed. General paint chipping and deterioration was observed on the siding. It is suggested that a "Licensed General Contractor" be contacted for further evaluation and repair.

Exposed hole in siding (East side of home)

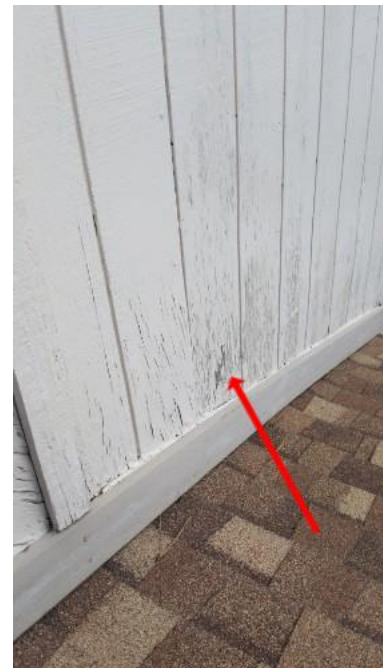
Paint cracking and deterioration on siding above garage (South side of home)

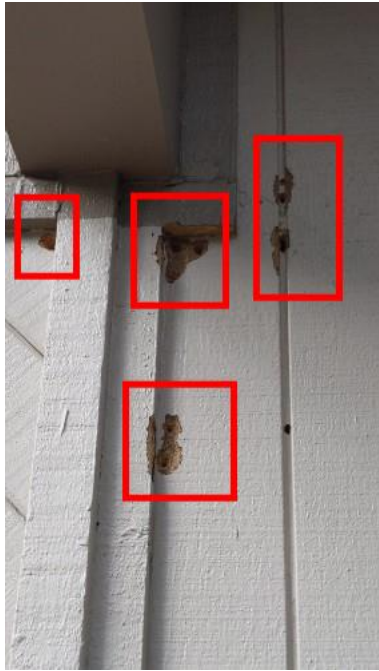
Holes made by animals or insects were observed on the South side of the home (above the garage). Recommend a pest inspector further evaluate.

Holes in siding by animal or insects on (South side of home above garage)

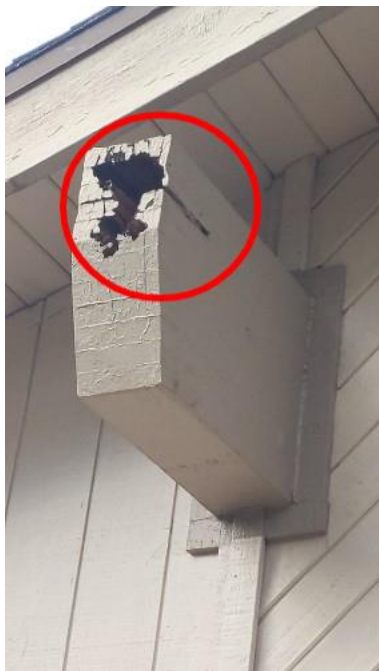
Wood beam deterioration

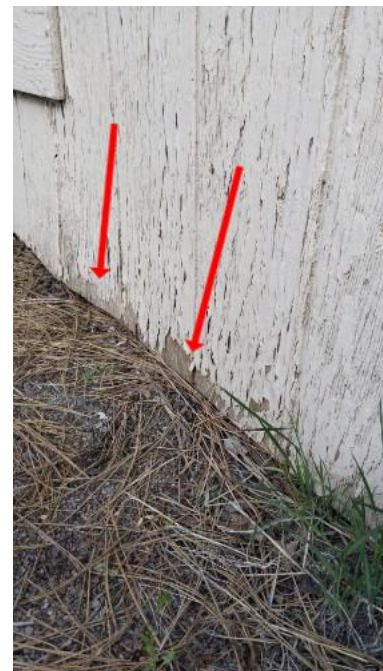
Paint peeling and deterioration

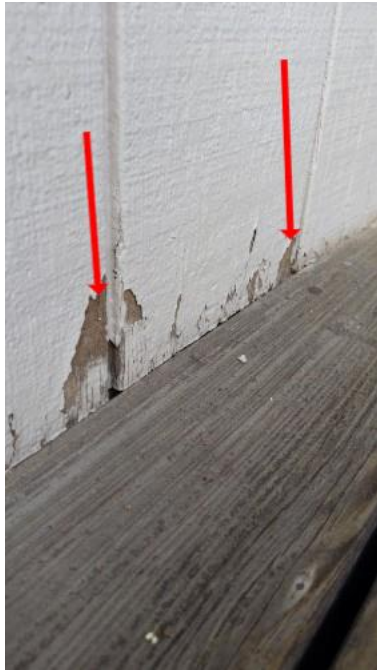
Paint peeling on siding

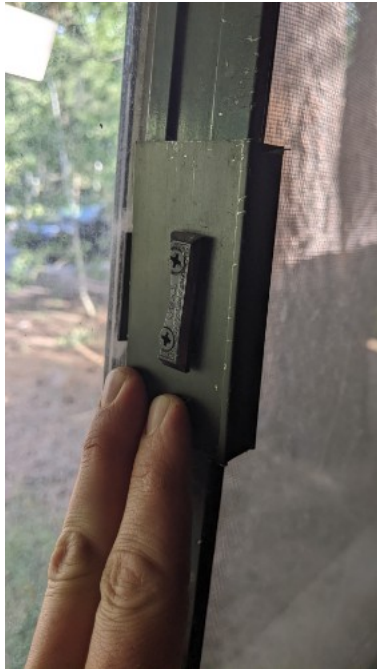
The window in the Southeast corner bedroom did not latch/lock at the time of inspection. It is suggested that a "Licensed General Contractor" be contacted for further evaluation and repair.

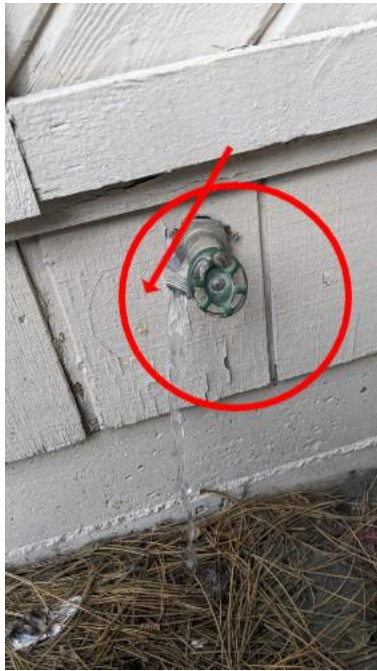
Two of the three outdoor faucets were not working at the time of the inspection. The one operable faucet was on the West side of the home closest to the garage. The operating faucet was not properly secured to the house. It is suggested that a "Licensed Plumbing Contractor" be contacted for further evaluation and repair.

This faucet was working but not properly attached

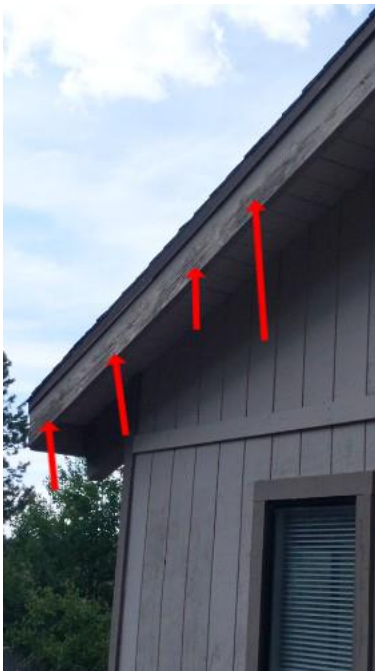
Fascia paint is deteriorating

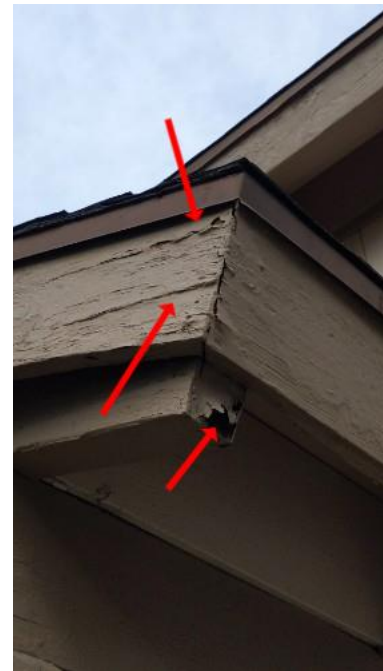
Fascia paint deterioration

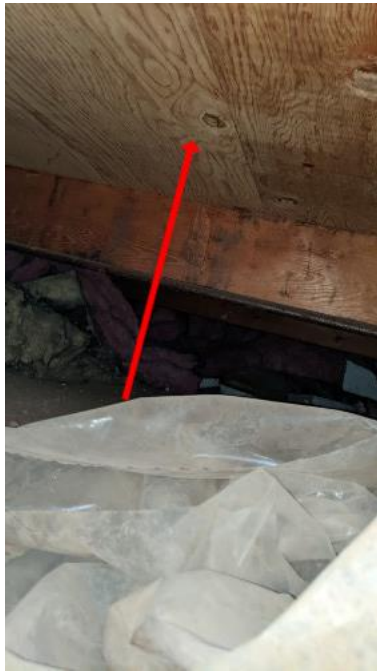
Falling and displaced insulation was observed. No insulation installed under flooring. Recommend qualified professionals correct and add insulation for energy efficiency.

No insulation under flooring

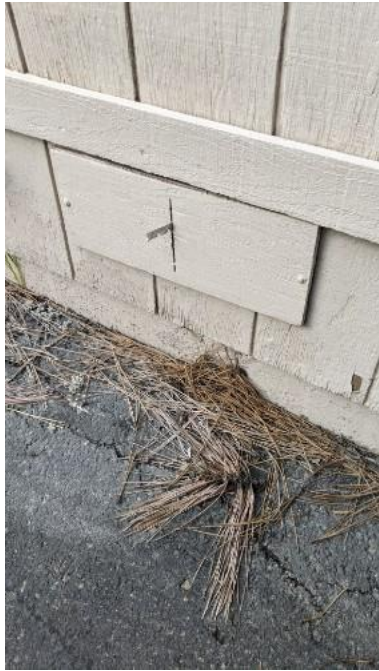
No vapor barrier installed. This can result in unwanted moisture. Crawlspace vents were covered shut at the time of inspection which does not allow airflow. Recommend a qualified professional install vapor barrier and evaluate ventilation.

Crawlspace vents sealed up - no ventilation

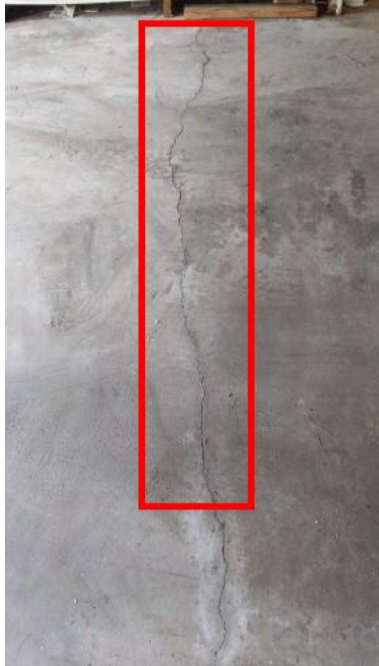
Hairline crack

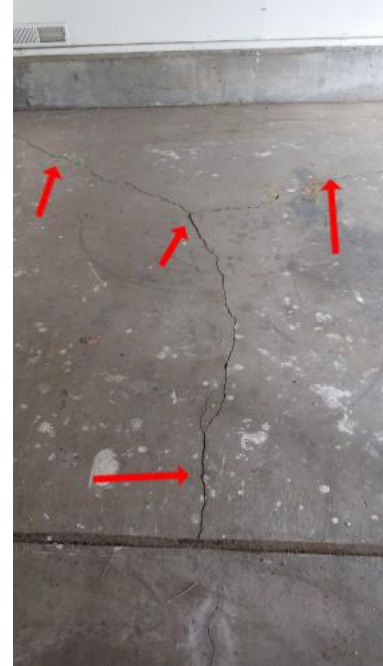
Hairline crack

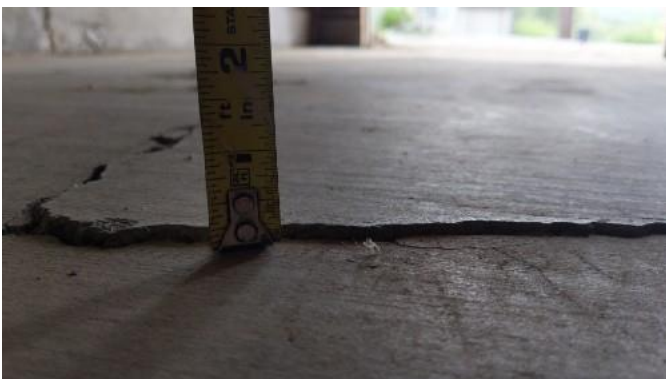
Settlement - near 1/4" height in crack

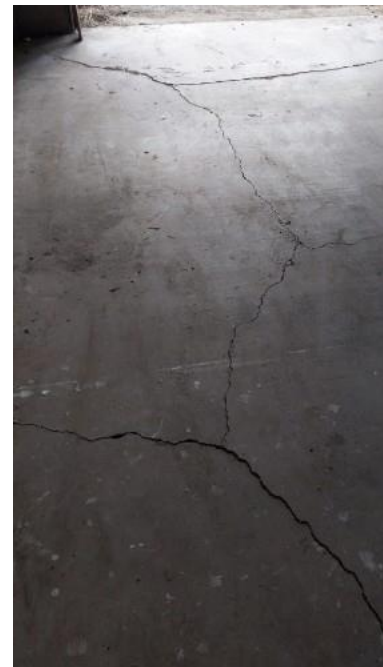
Cracks in garage floor

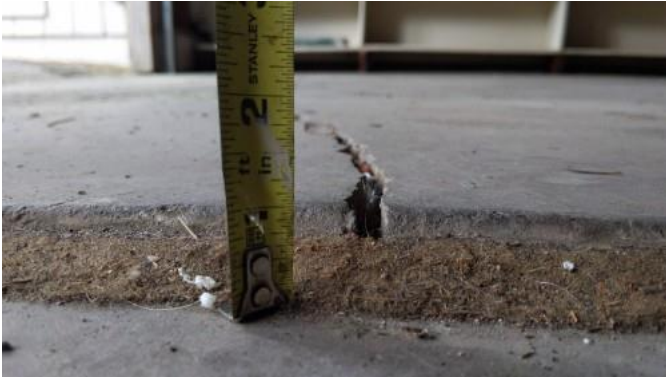
Middle divider of the two car garage is raised nearly an inch

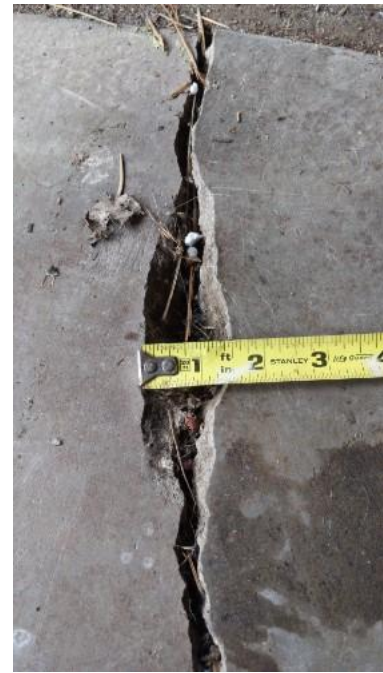
Largest crack in garge has 1 and 1/2" gap

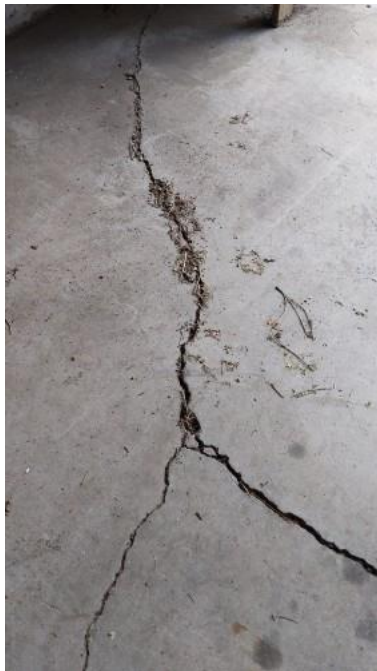
Crack in garage floor

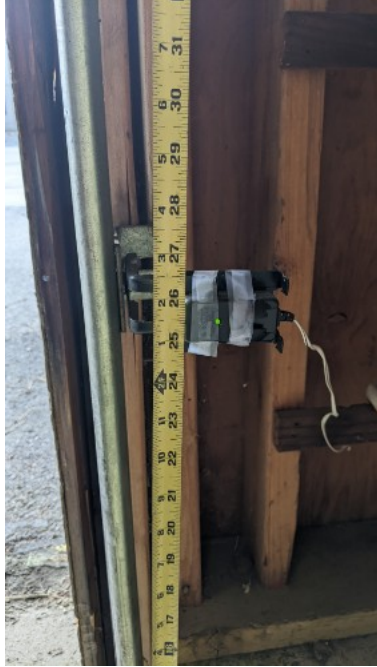
The mechanical garage door has the door safety sensor mounted too high (25"). The recommended height of installation is 4-6" from the ground. This is a safety feature and should be corrected by a qualified professional.

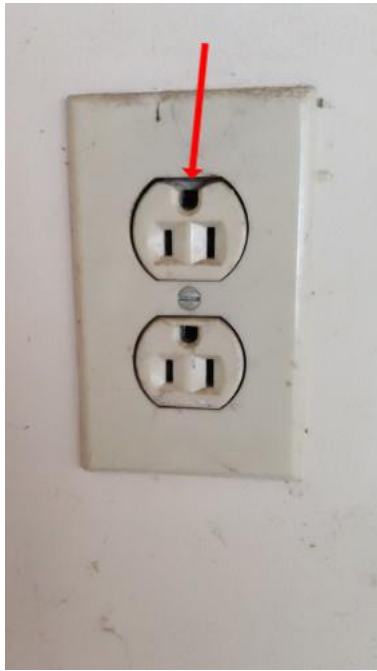
Damaged outlet

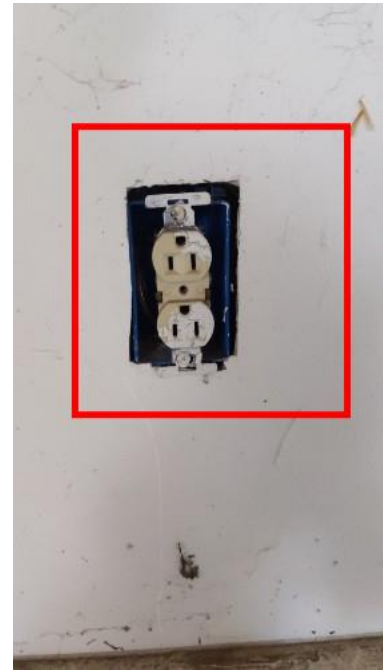
No cover plate

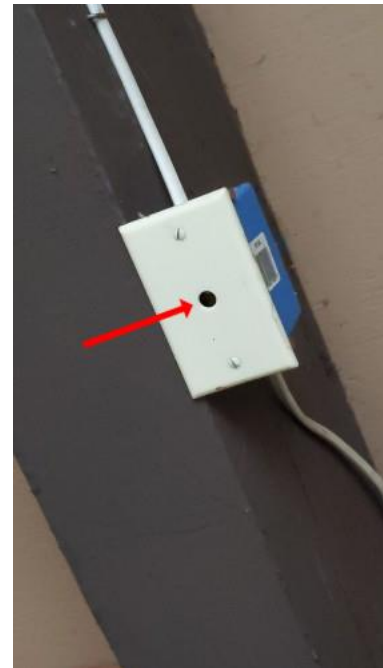
Complete cover plate recommended

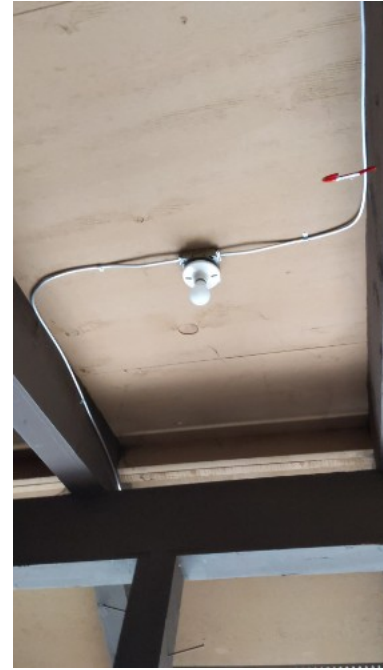
Lights not operating under normal controls. It is suggested that a "Licensed Electrical Contractor" be contacted for further evaluation and repair.

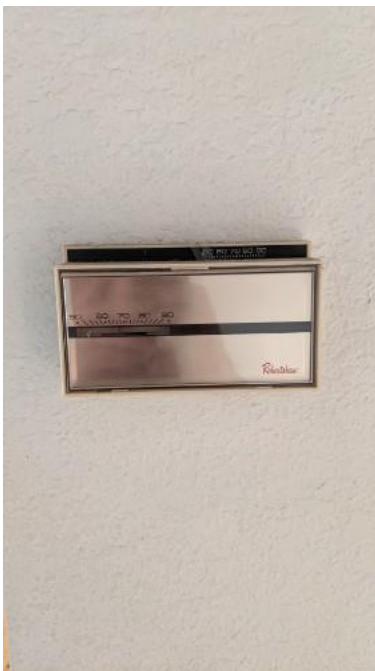
The thermostat on the first floor worked with normal operating procedures. The thermostat on the 2nd floor did not work with normal operation. It is suggested that a "Licensed Electrical Contractor" be contacted for further evaluation and repair.

2nd floor thermostat - not working

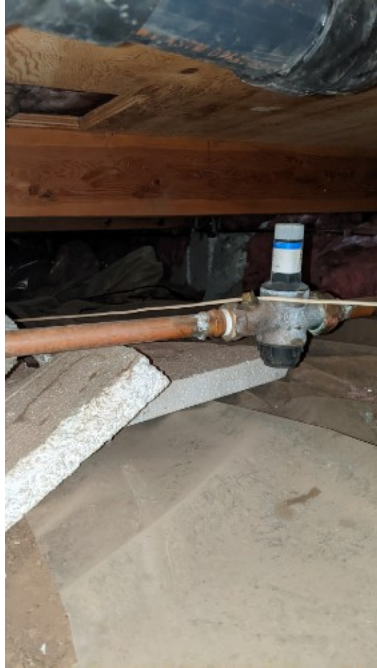
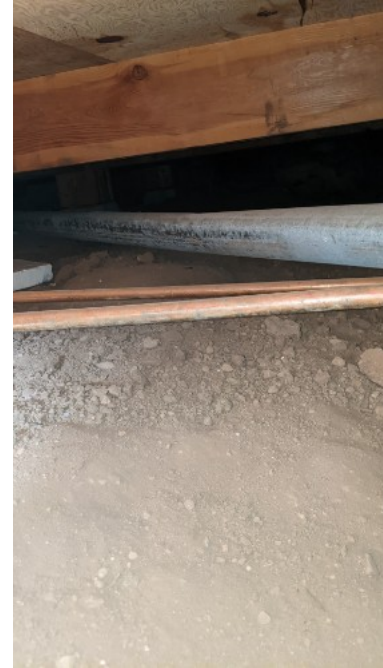
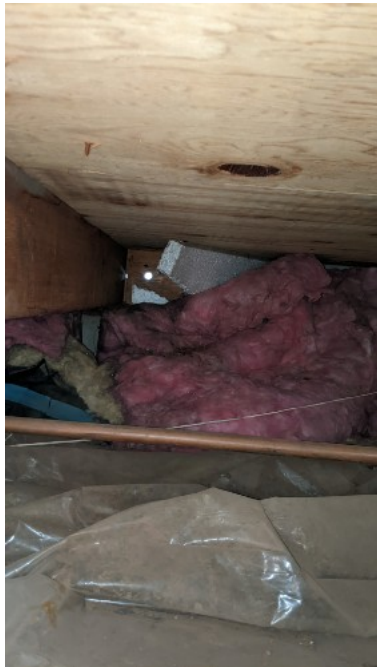
Since the pipes can be exposed to cold temperatures, recommend installation of insulation wrap at all valves and associated piping. Although insulation can be purchased at most hardware stores, client is advised to consult with a licensed plumber for information on piping within unheated areas.

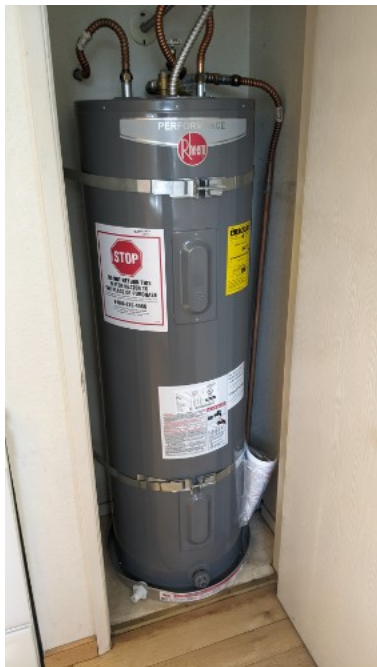
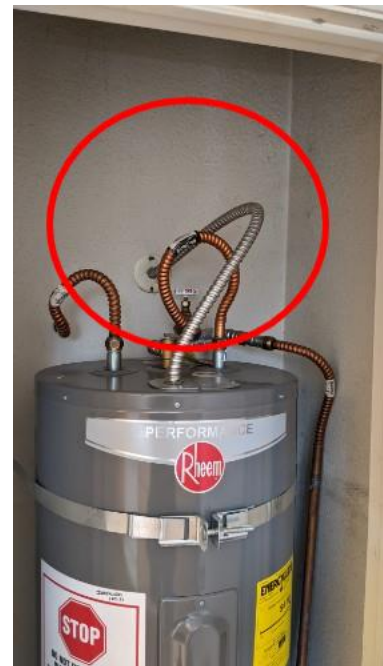
No expansion tank installed. The expansion tank equalizes pressure throughout the plumbing system by providing a space for hot water to flow into. Without an expansion tank, pressure would be distributed to the entire plumbing system, straining it and decreasing its lifespan. It is suggested that a "Licensed Plumbing Contractor" be contacted for further evaluation and installation.

No expansion tank

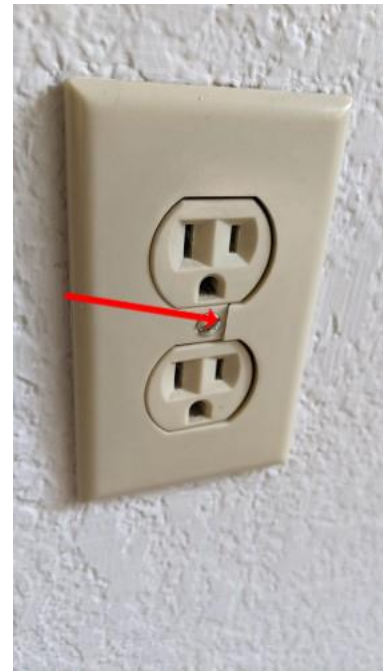
Cracked cover plate

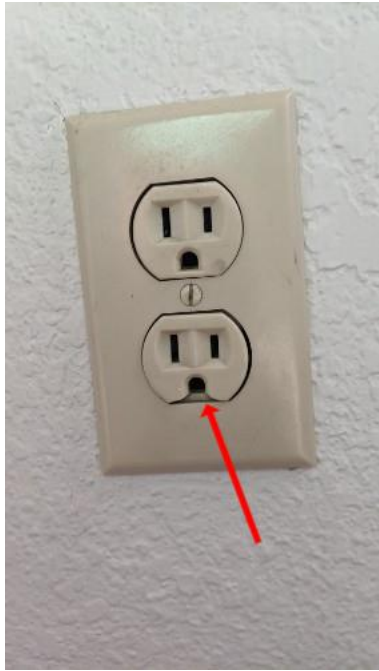
Damaged outlet

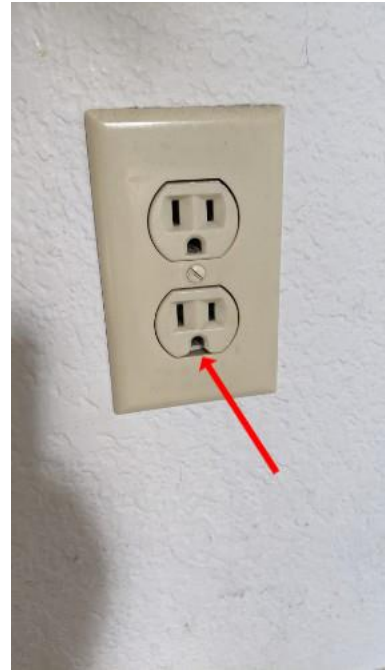
Damaged outlet

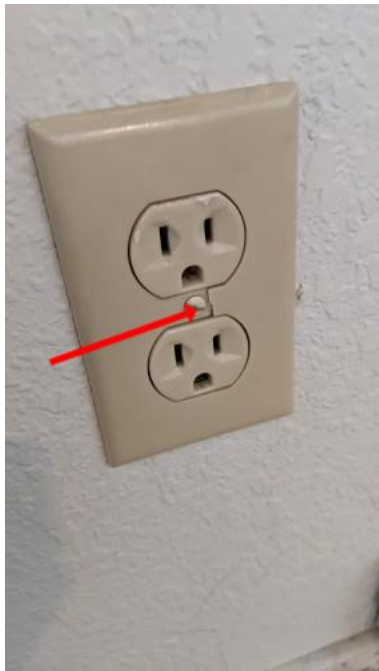
Cracked cover plate

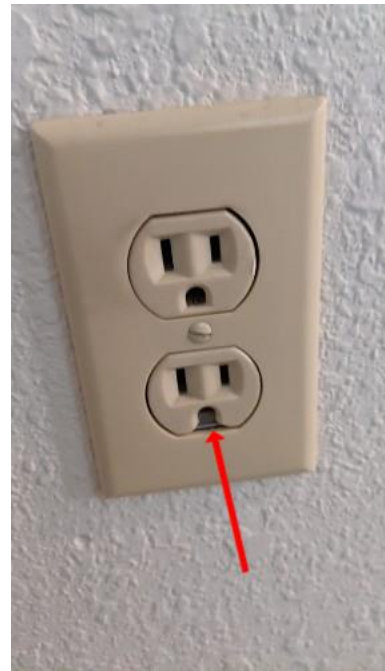
Damaged outlet

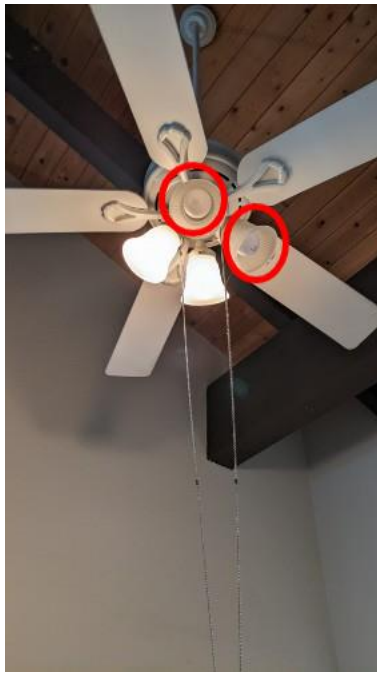
Ceiling fan bulbs out

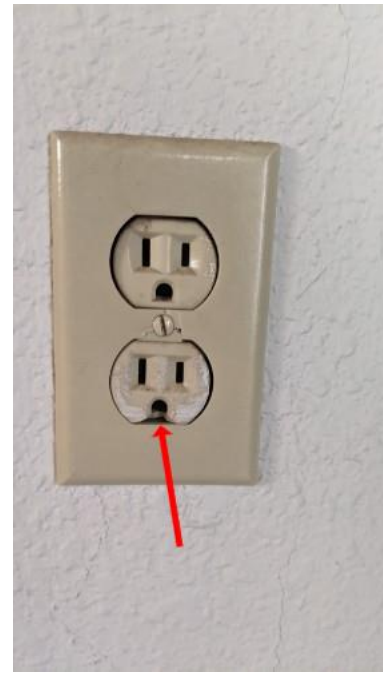
Damaged outlet

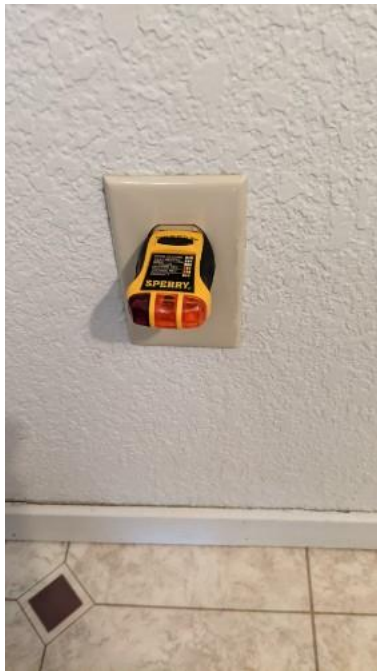
No power to outlet in upstairs bathroom

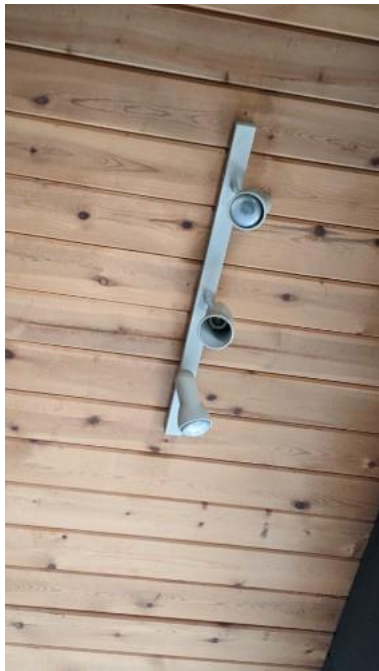
No power to ceiling lights on 2nd floor

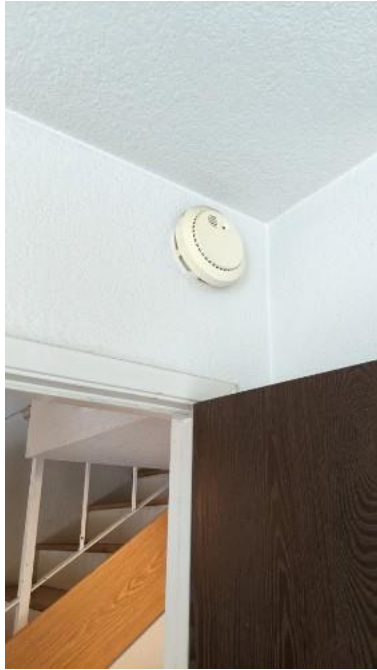
The smoke detector(s) did not respond to the test button in the primary bedroom. A smoke detector was missing or removed at the Southeast corner bedroom. Smoke detectors are required in all sleeping rooms. Recommend adding smoke detectors for safety.

Primary BR - no response when tested
