# Inspection Report

## **ASAP Home Inspections LLC**

10555 Sample Drive Truckee, CA 96161

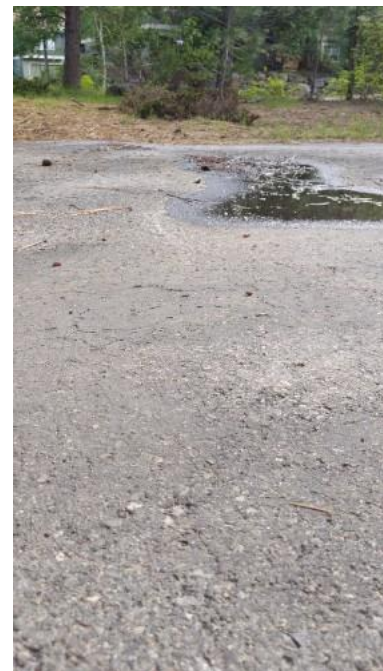
(Repair) Common cracks, major cracks and settlement were observed in the driveway making it an uneven surface. The major crack was 2" wide at the widest point. The driveway shows evidence of ponding. The driveway should be sloped to allow for proper drainage.

Large crack on side of driveway

Recommend a qualified professional evaluate and repair or replace as needed.

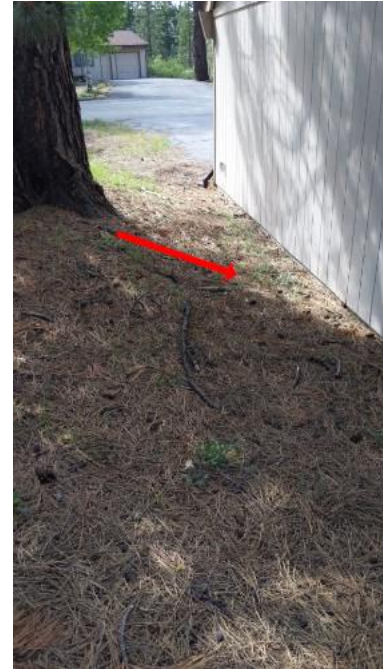
The grading slopes towards the South and East side of home/garage. The East side has a garage access door. This can allow water penetration. Recommend qualified professional evaluate and repair.

Slopes towards garage access door and East side of home.

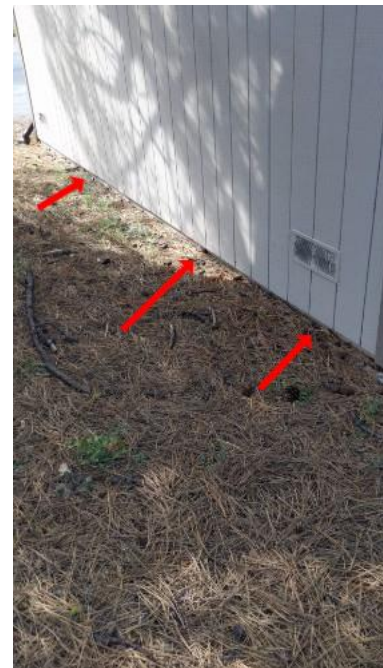
East side of home

6-8" of ground clearance recommended. Earth/soil is in contact with wood siding which allows deterioration and moisture penetration. Recommend the wood siding be at least 6" from Earth/soil/ground.

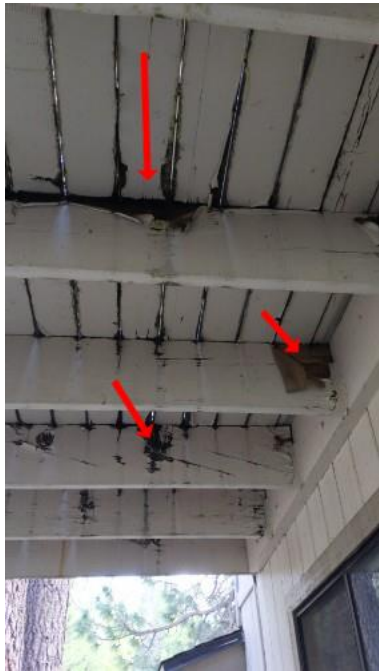
Paint peeling and deterioration under the deck

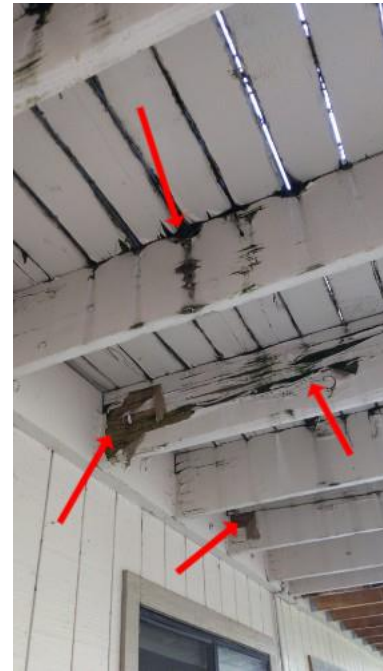
Paint peeling and deterioration under the deck

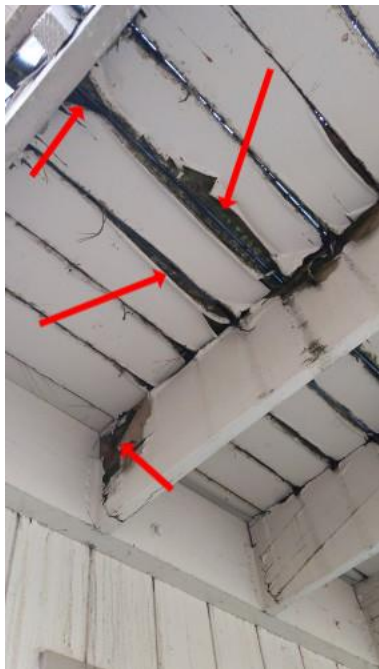
Paint peeling and deterioration under the deck

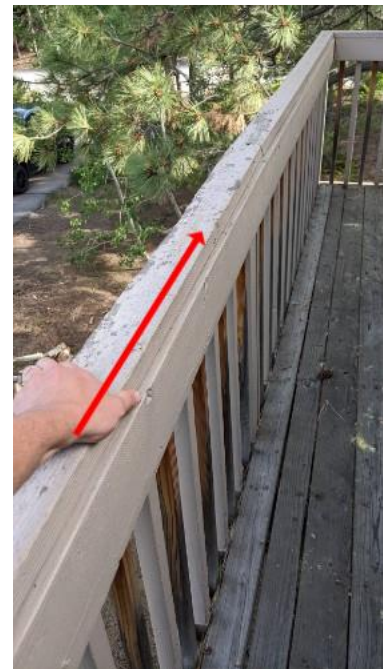
(Safety)The back deck railing (East) was loose at the time of inspection. This is a safety hazard. Multiple exposed nails raised above 1/4" were observed throughout the deck. These are a tripping hazard. It is suggested that a "Licensed General Contractor" be contacted for further evaluation and repair.

Back deck railing was loose

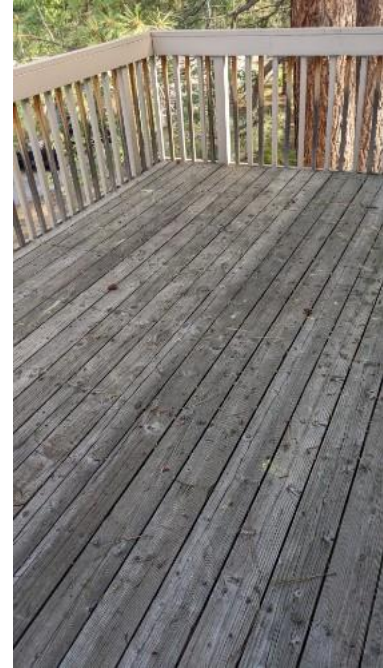
Deck surface weathered

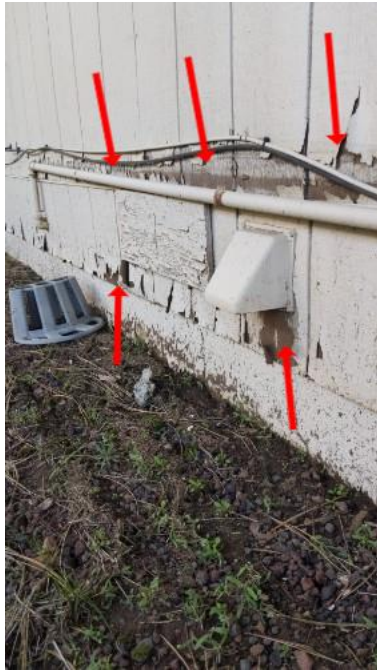
Paint peeling and deterioration on East side of home

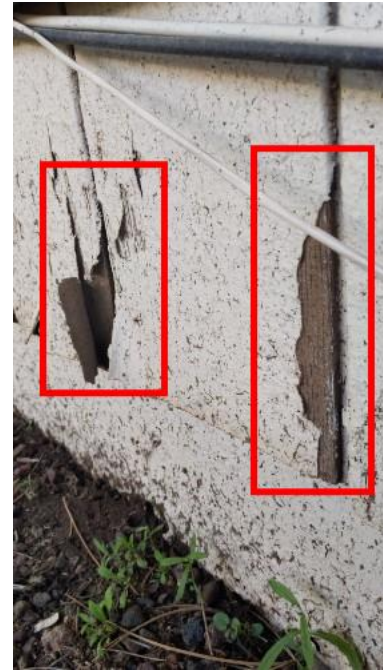
Paint peeling and deterioration exposed wood siding

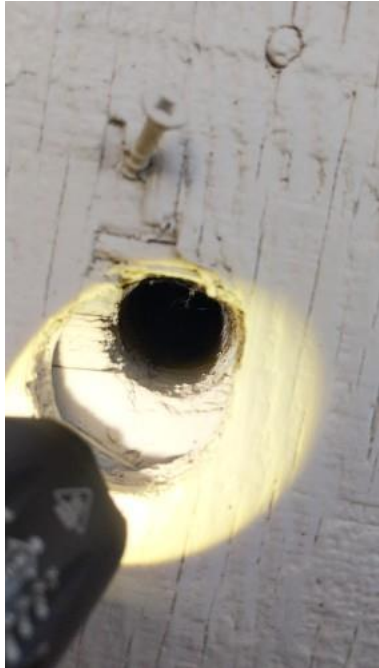
Exposed hole in siding (East side of home)

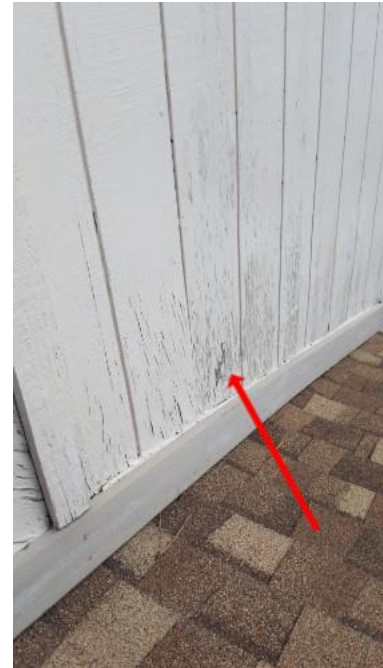
Paint cracking and deterioration on siding above garage(South side of home)

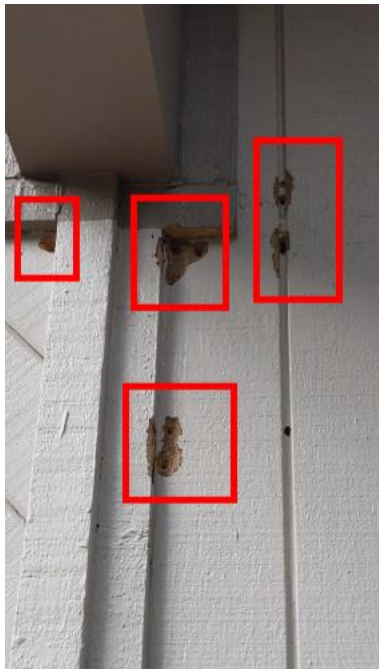
Holes made by animals or insects were observed on the South side of the home (above the garage). Recommend a pest inspector further evaluate.

Holes in siding by animal or insects on (South side of home above garage)

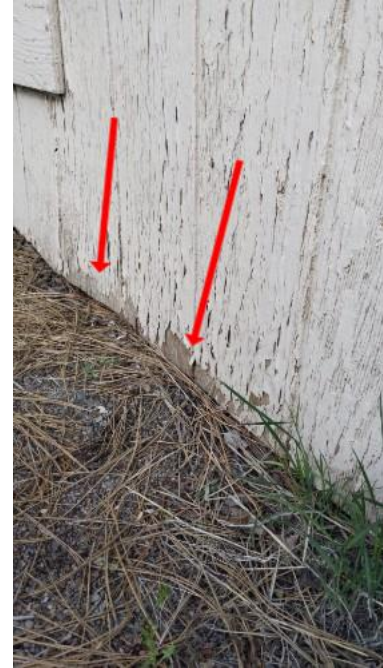
Paint peeling and deterioration

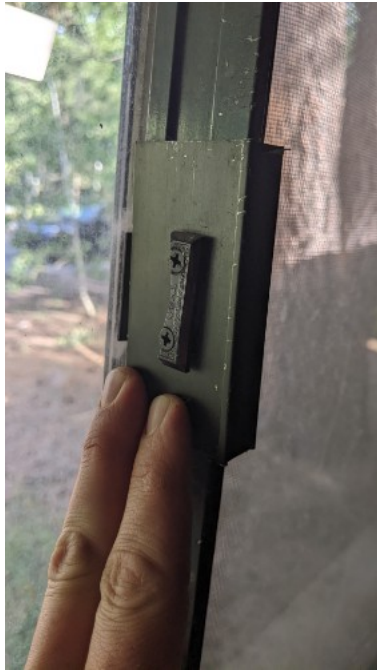
The window in the Southeast corner bedroom did not latch/lock at the time of inspection. It is

suggested that a "Licensed General Contractor" be contacted for further evaluation and repair.

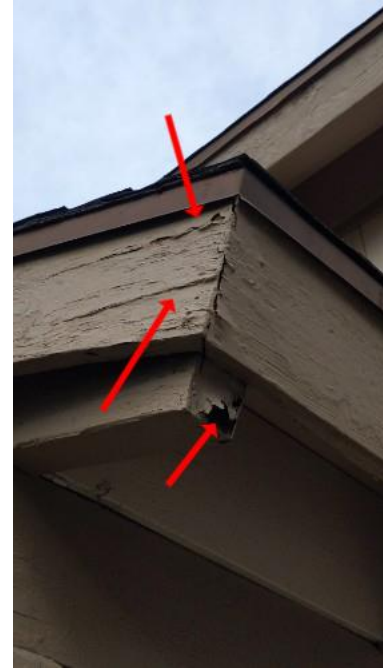
Fascia paint deterioration

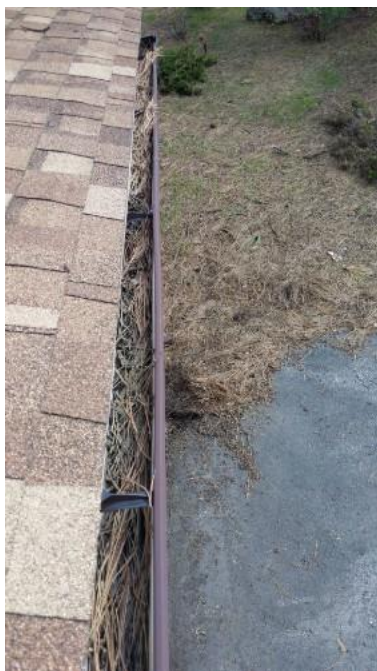
The gutters were filled with leaves and debris at the time of the inspection. Suggest cleaning and removal of debris on a regular basis. This condition can cause water penetration at the eave area. Recommend the end of the gutter to exit at least 6' from home. It is suggested that a "Licensed General Contractor" be contacted for further evaluation and repair.

Gutter filled with debris

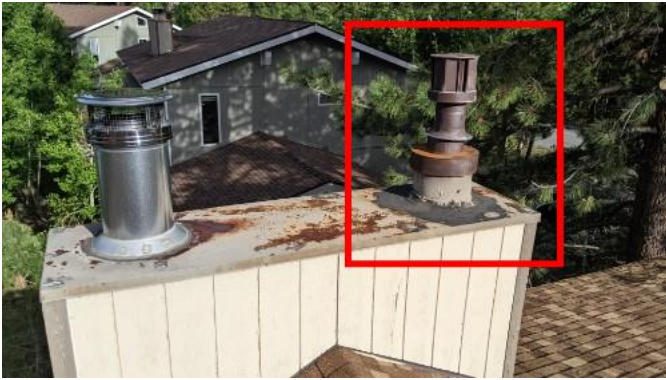
Paint peeling/deterioration on chimney siding was observed. The chimney shows signs of rust and corrosion. It is suggested that a "Licensed General Contractor" be contacted for further evaluation and repair.

Right is your chimney, left is neighbors. Rust and corrosion observed

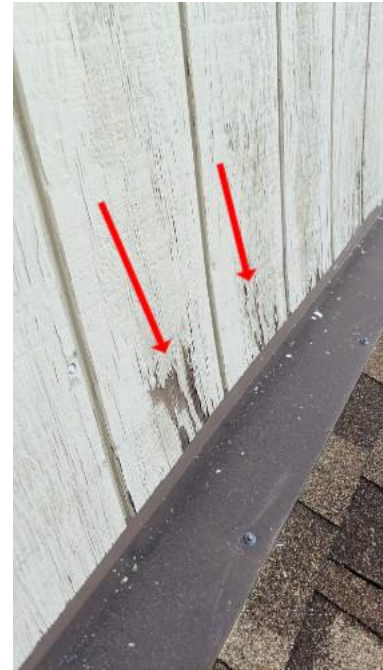
Paint peeling/deterioration on chimney siding

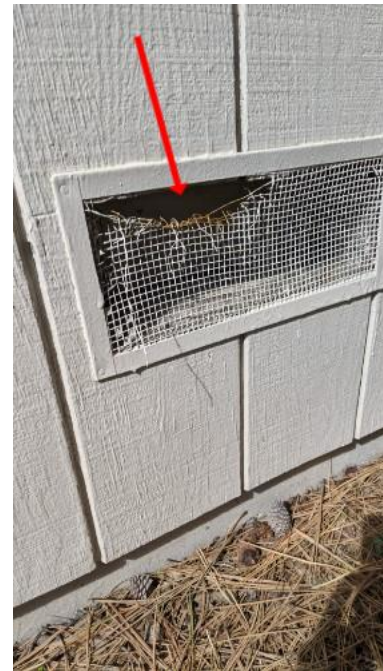
Crawlspace vent damaged

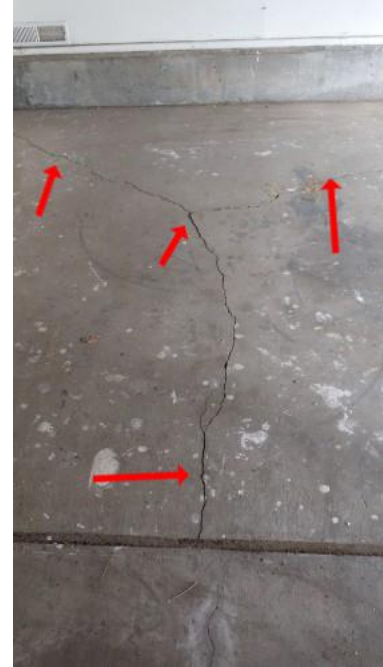
Hairline crack

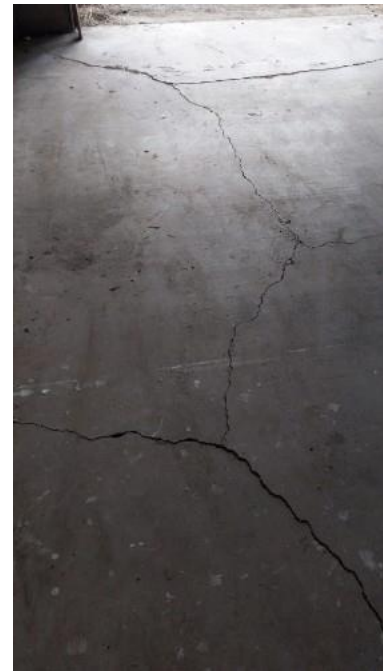
Cracks in garage floor

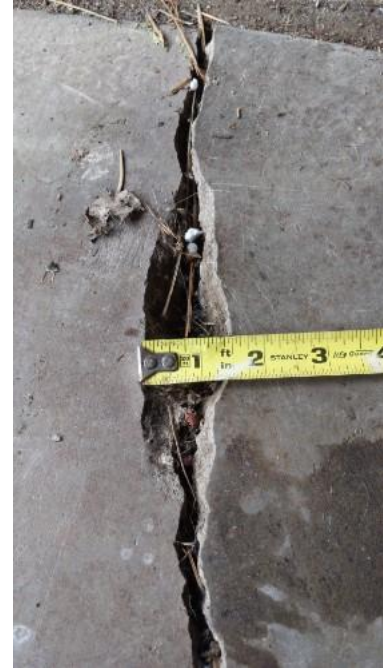
Largest crack in garge has 1 and 1/2" gap

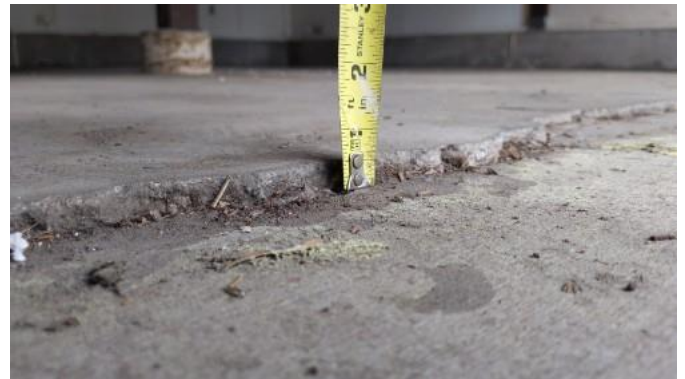
Garage floor crack raised 1/2"

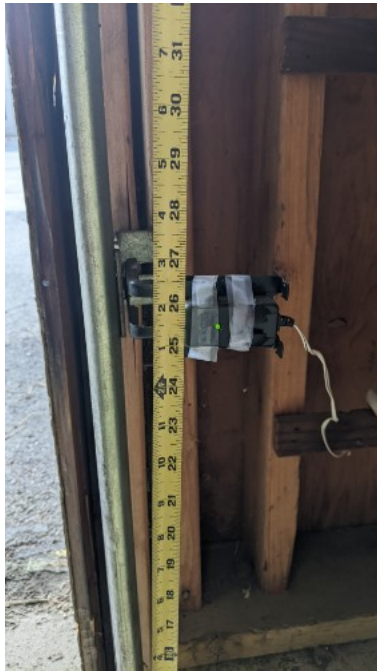
The mechanical garage door has the door safety sensor mounted too high (25"). The recommended height of installation is 4-6" from the ground. This is a safety feature and should be corrected by a qualified professional.

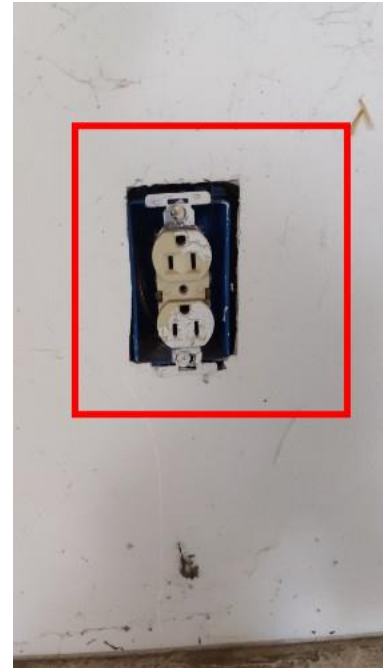
No cover plate

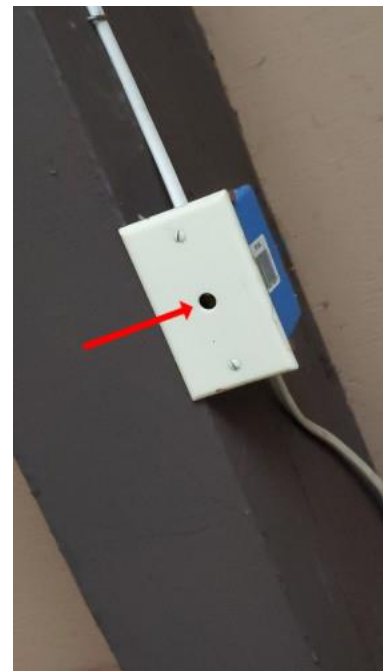
Complete cover plate recommended

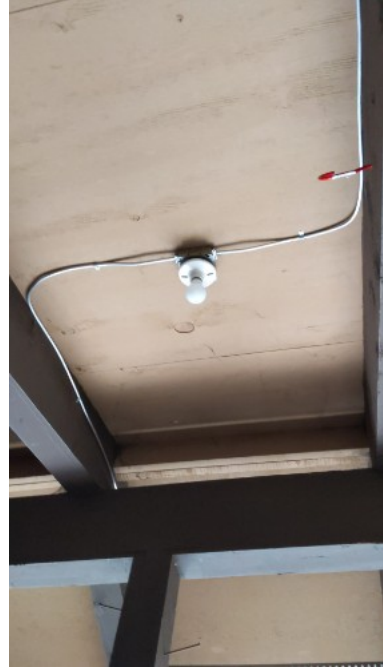
Lights not operating under normal controls. It is suggested that a "Licensed Electrical Contractor" be contacted for further evaluation and repair.

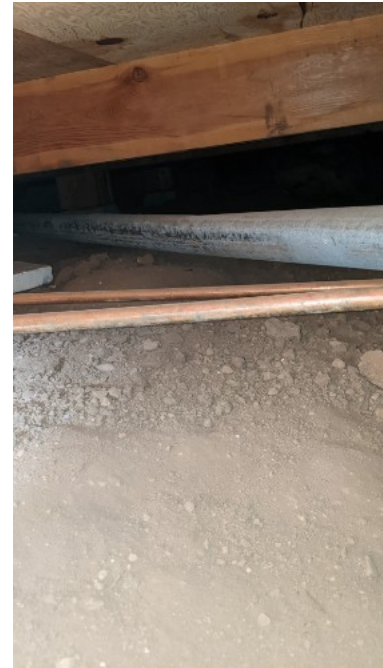
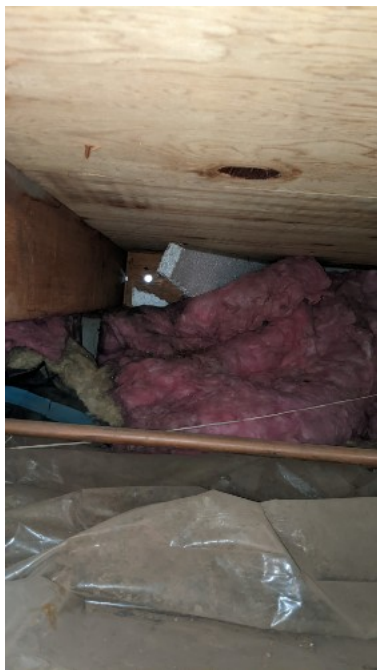
Since the pipes can be exposed to cold temperatures, recommend installation of insulation wrap at all valves and associated piping. Although insulation can be purchased at most hardware stores, client is advised to consult with a licensed plumber for information on piping within unheated areas.

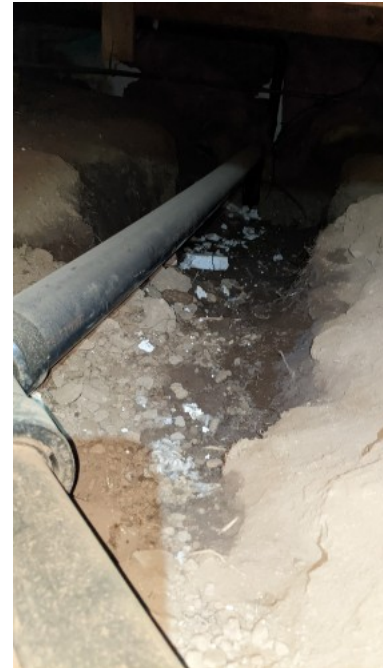
Minor gurgling was heard from the drain when the water was run. This is sometimes typical of an older house or if the house is not older, this condition may indicate a venting problem. Client should consult a licensed plumber for further information.

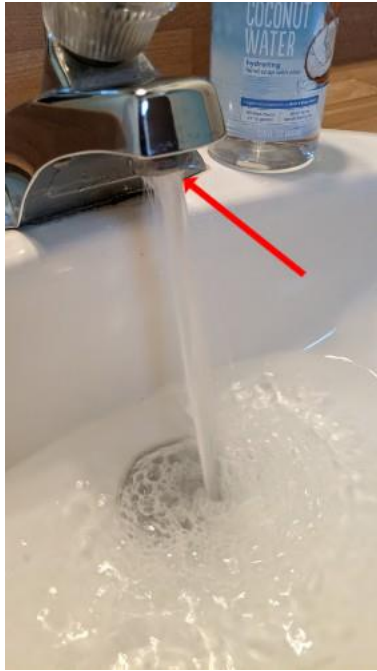
Water was shooting out of the upstairs bathroom faucet and spilling onto the floor. Recommend

Change aerator

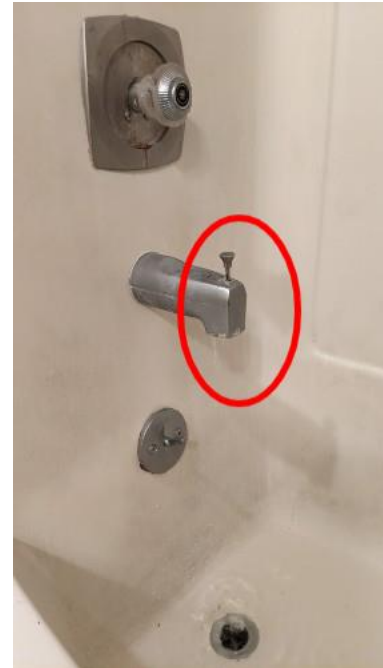
Shower diverter leaking when engaged

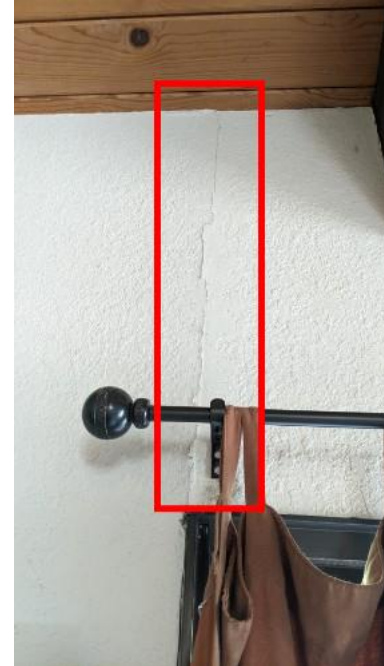
Minor settlement cracks were observed on the upstairs East wall. Recommend monitoring these cracks and sealing.

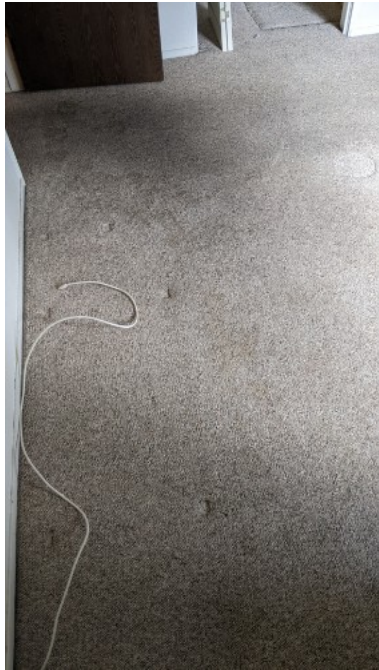
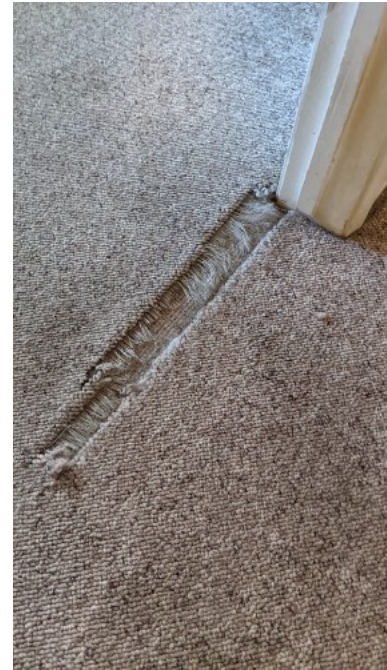
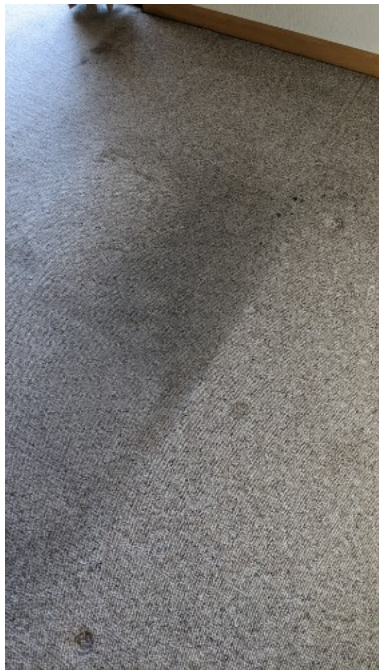
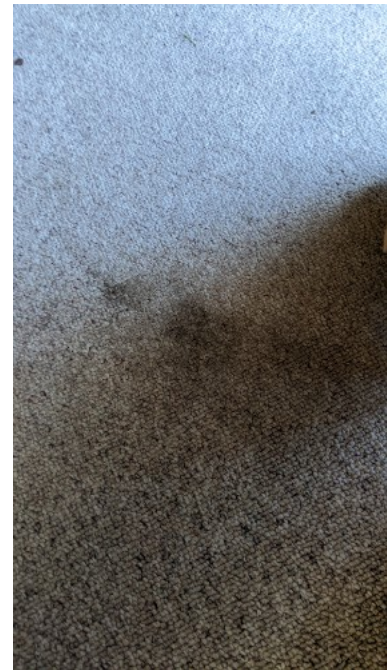
The carpets were torn / ripped on the 1st floor. Discoloration and stains were observed in various locations throughout the home. Recommend replacing the carpets.

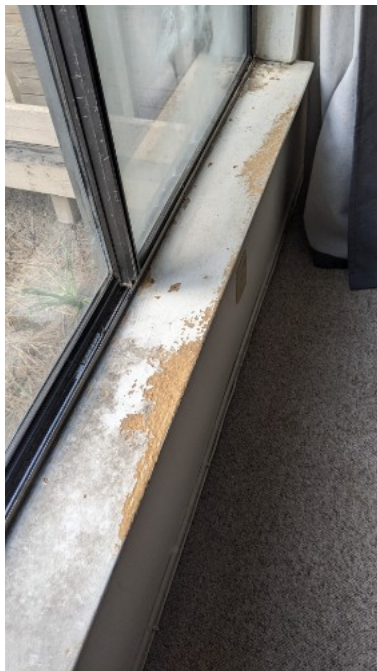
The windowsill in the primary bedroom was deteriorated at the time of inspection. It is suggested that a "Licensed General Contractor" be contacted for further evaluation and repair.

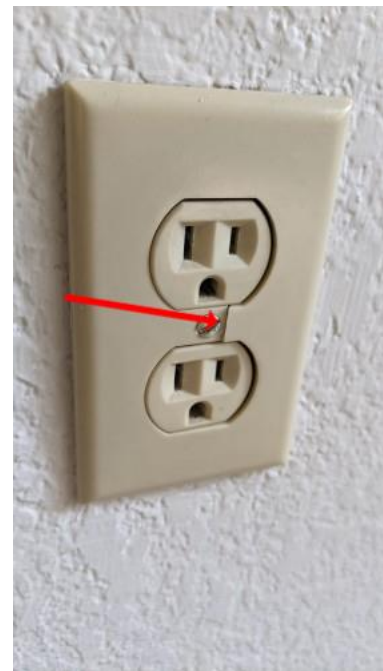
Cracked cover plate

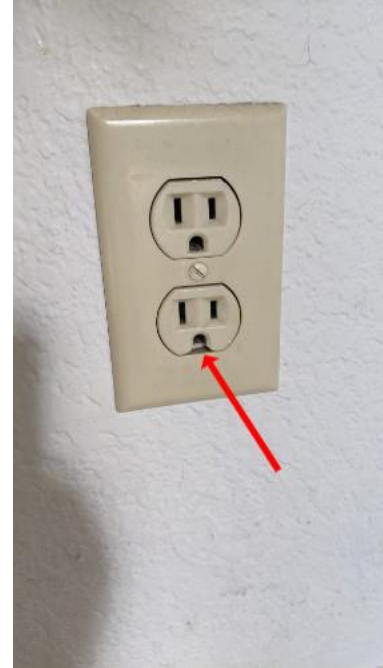
Damaged outlet

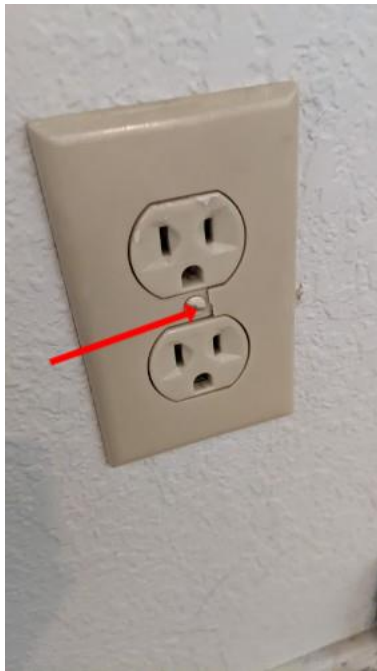
Cracked cover plate

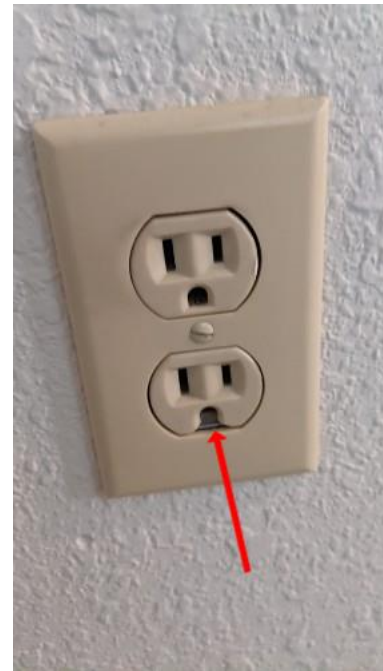
Damaged outlet

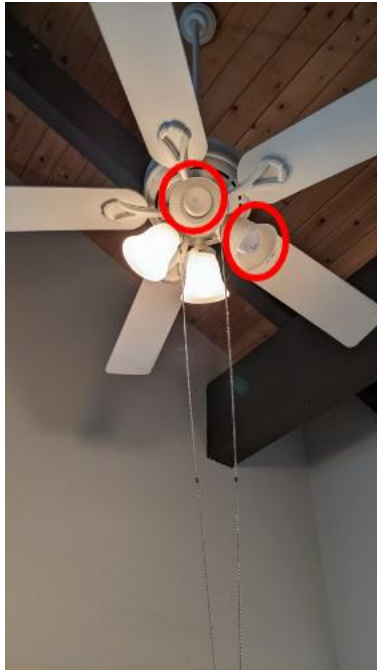
Ceiling fan bulbs out

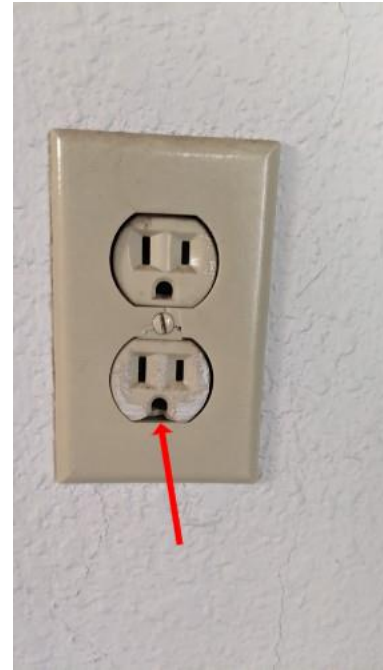
Damaged outlet

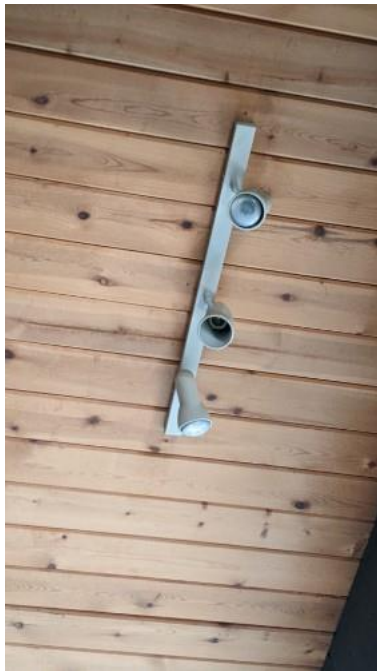
No power to ceiling lights on 2nd floor

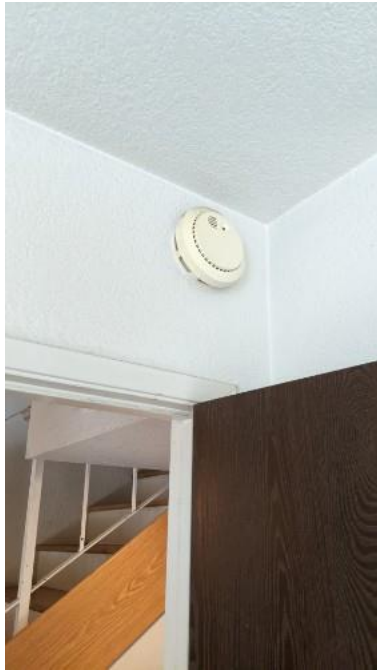
The smoke detector(s) did not respond to the test button in the primary bedroom. A smoke

Primary BR - no response when tested

detector was missing or removed at the Southeast corner bedroom. Smoke detectors are required in all sleeping rooms. Recommend adding smoke detectors for safety.

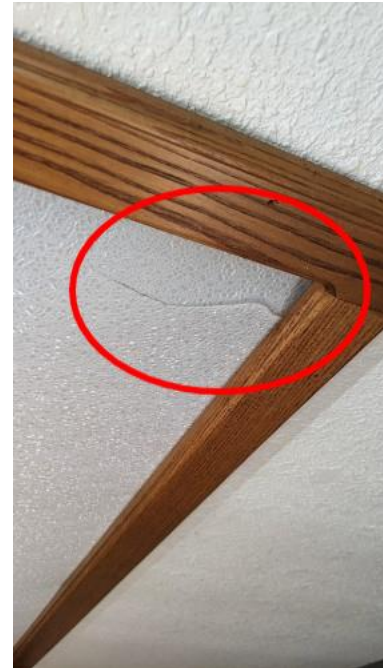
The kitchen light cover was cracked and damaged. Recommend replacing but this is a cosmetic repair, the light is still operable.

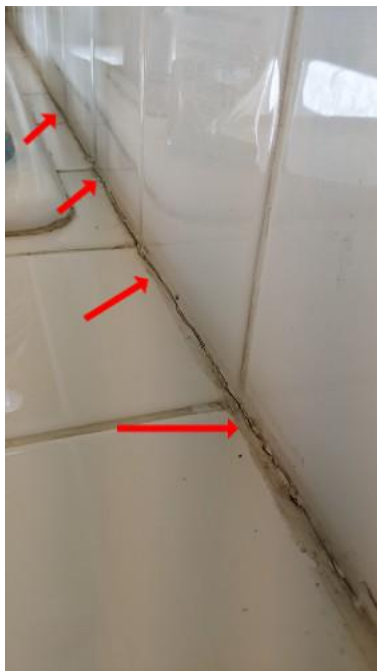
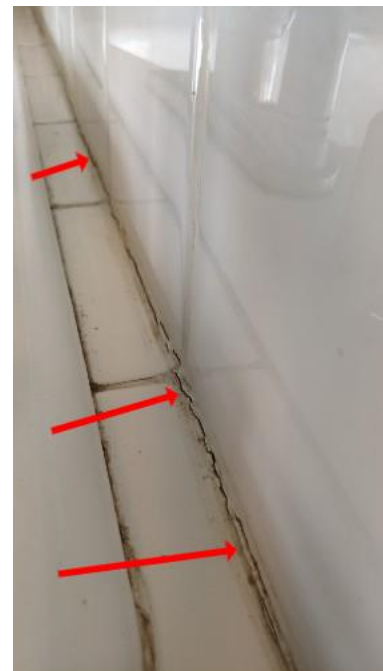
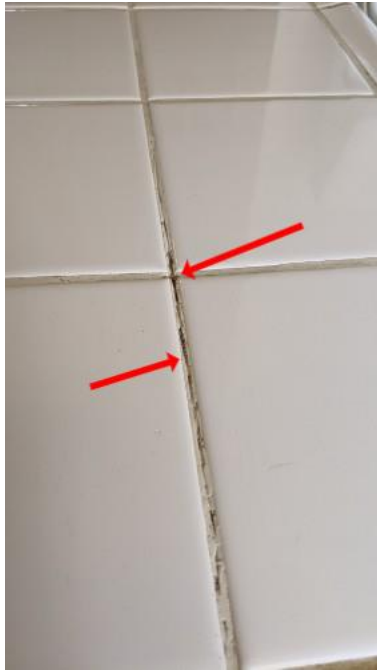
The caulking grout behind the sink and one spot on the counter was deteriorated. Recommend resealing to prevent water intrusion.
