Inspection Report

ASAP Home Inspections LLC

10555 Sample Drive Truckee, CA 96161

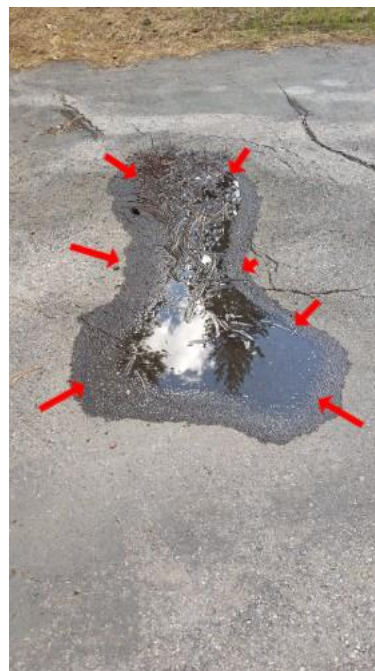
(Repair) Common cracks, major cracks and settlement were observed in the driveway making it an uneven surface. The major crack was 2" wide at the widest point. The driveway shows evidence of ponding. The driveway should be sloped to allow for proper drainage.

Ponding in driveway

Recommend a qualified professional evaluate and repair or replace as needed.

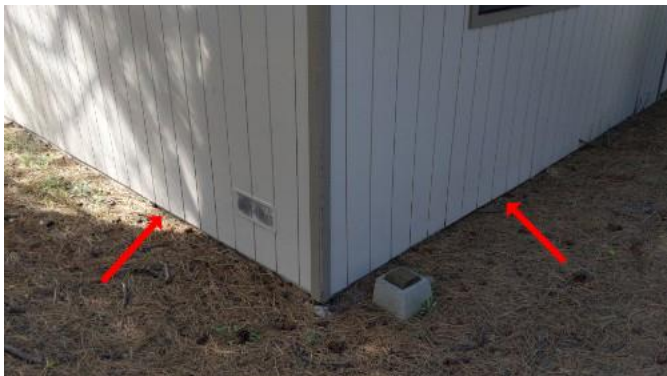
The grading slopes towards the South and East side of home/garage. The East side has a garage access door. This can allow water penetration. Recommend qualified professional evaluate and repair.

View of both East and South side exterior

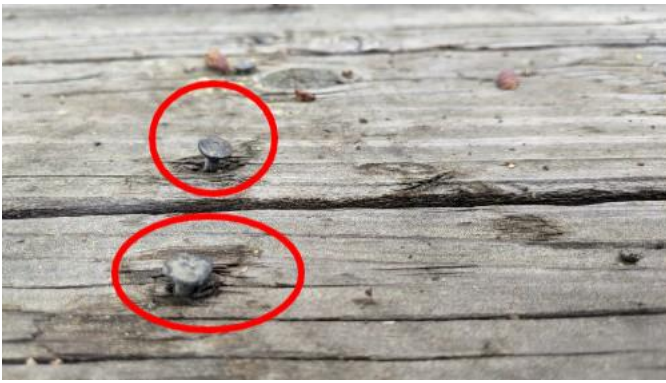
(Safety)The back deck railing (East) was loose at the time of inspection. This is a safety hazard. Multiple exposed nails raised above 1/4" were observed throughout the deck. These are a tripping hazard. It is suggested that a "Licensed General Contractor" be contacted for further evaluation and repair.

Exposed nails on deck floor surface

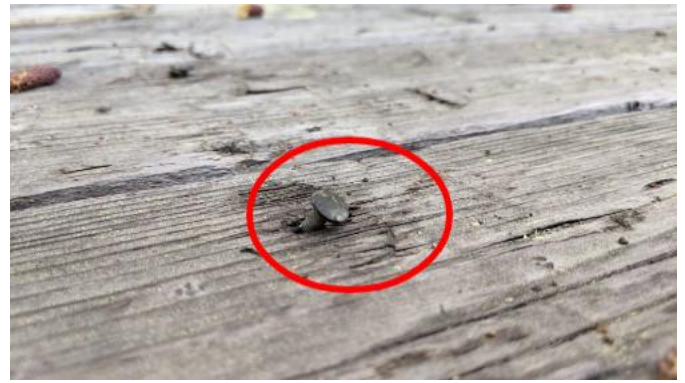
Exposed nails on deck floor surface

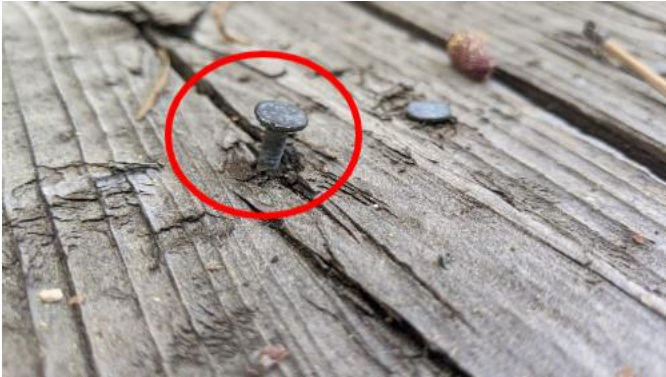
Exposed nails on deck floor surface

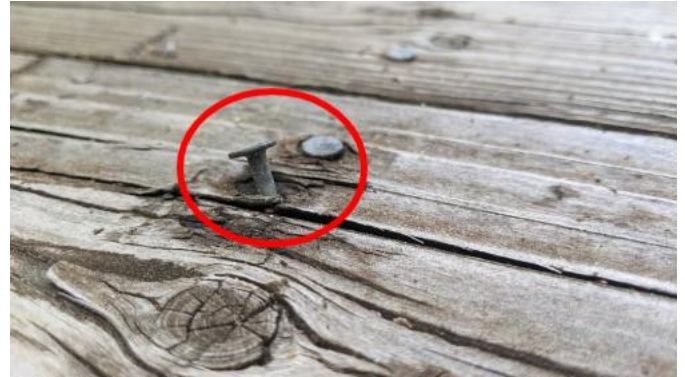
Exposed nails on deck floor surface

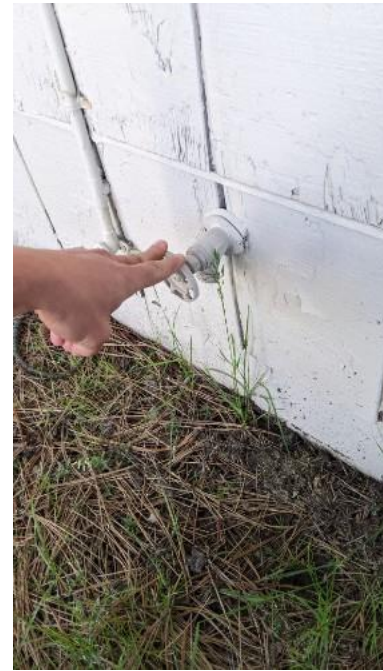
Two of the three outdoor faucets were not working at the time of the inspection. The one operable faucet was on the West side of the home closest to the garage. The operating faucet was not properly secured to the house. It is suggested that a "Licensed Plumbing Contractor" be contacted for further evaluation and repair.

Faucet on back of home (East) not working

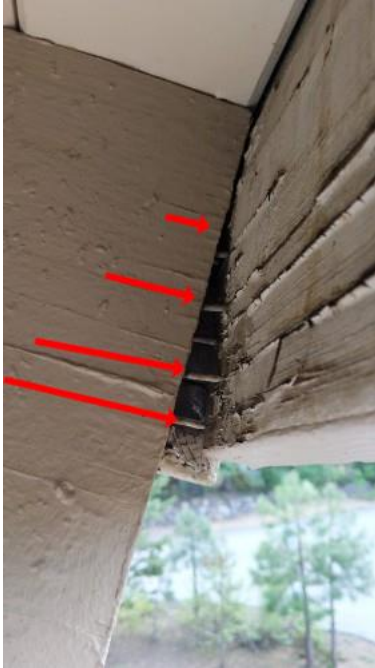
One of the fascias on the West side of home is bending away from the home and the nails are starting to pull away from the home. Other fascia paint deterioration was observed. It is suggested that a "Licensed General Contractor" be contacted for further evaluation and repair.

Fascia not secured

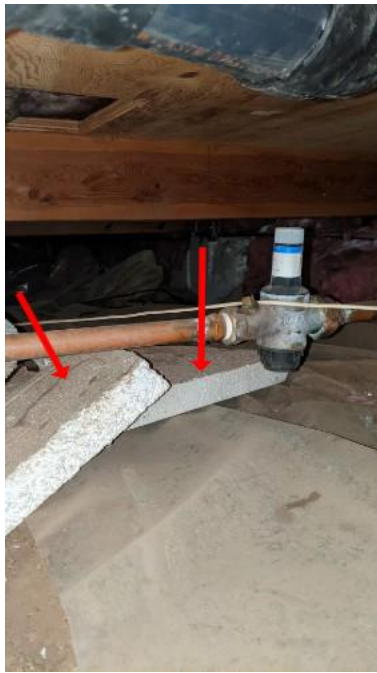
Falling and displaced insulation was observed. No insulation installed under flooring. Recommend qualified professionals correct and add insulation for energy efficiency.

Falling foam board insulation

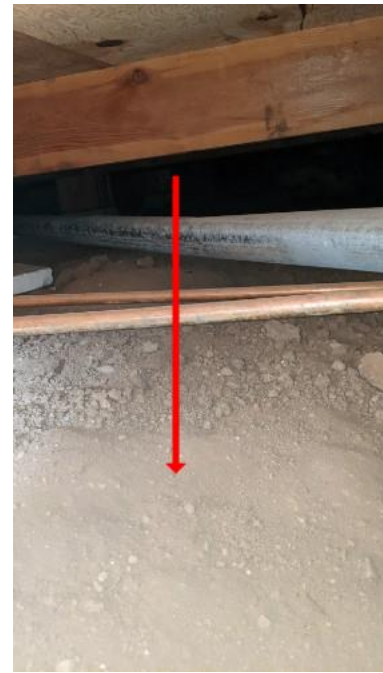
No vapor barrier installed. This can result in unwanted moisture. Crawlspace vents were covered shut at the time of inspection which does not allow airflow. Recommend a qualified professional install vapor barrier and evaluate ventilation.

Bare ground - no vapor barrier installed

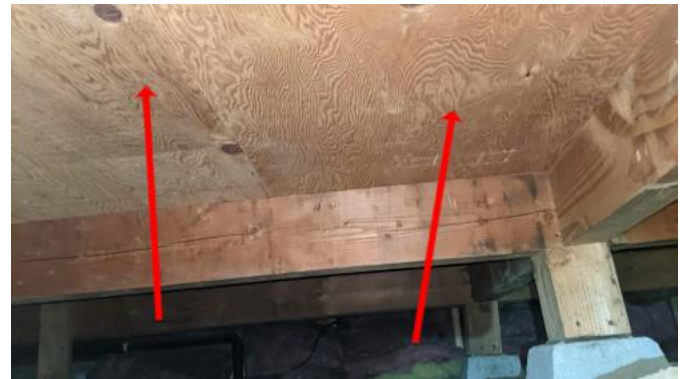
No insulation under flooring

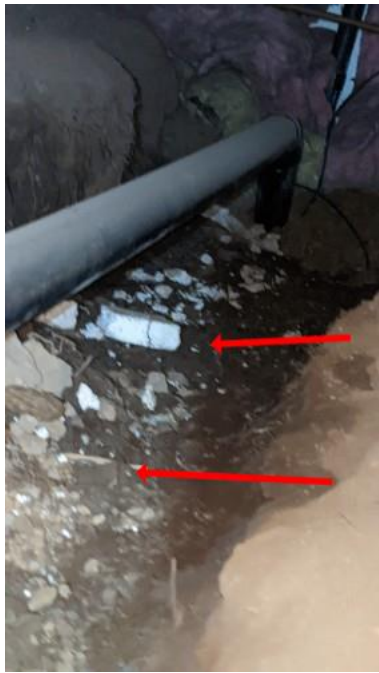
A damp/wet spot was observed under a drain pipe where the soil has fallen about 1 foot from the rest of the crawlspace. No active leak was observed. It is suggested that a "Licensed Plumbing Contractor" be contacted for further evaluation and repair.

Wet/damp area under drain pipe and soil is lower

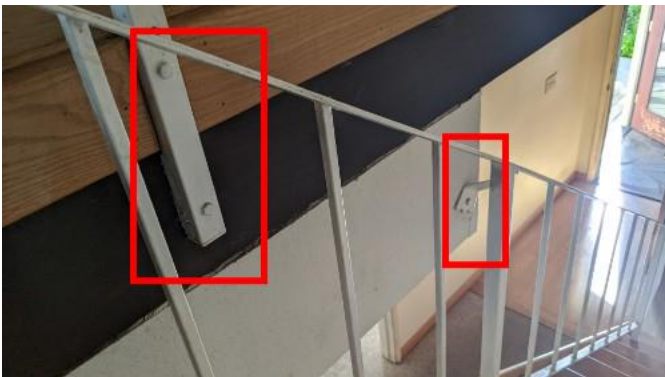
The stairway railing was loose at the time of inspection. It is suggested that a "Licensed General Contractor" be contacted for further evaluation and repair.

These bolts were loose

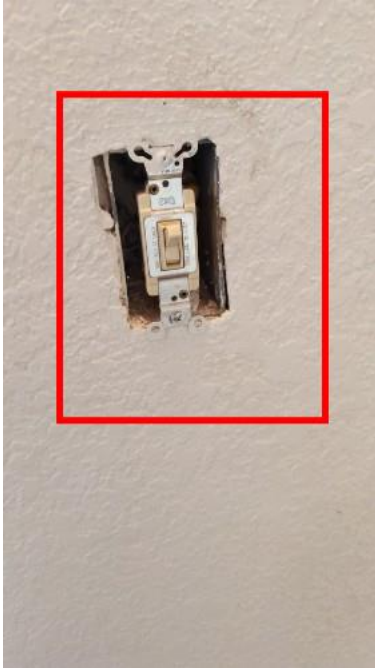
Damaged cover plates and outlets were observed throughout the home. A light control was missing a cover plate on the 1st floor. Bulbs were out in the downstairs bathroom and upstairs ceiling fan. No power to the upstairs ceiling lights. No power to the outlet by the wet bar and the outlets in the upstairs bathroom. It is suggested that a "Licensed Electrical Contractor" be contacted for further evaluation and repair.

No cover plate - 1st floor by stairway

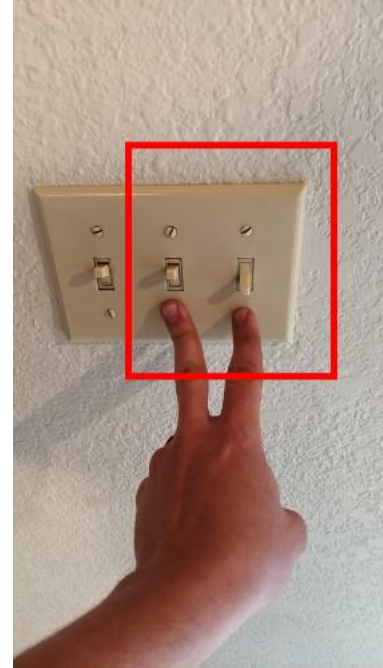
These two switches by front door did not operate

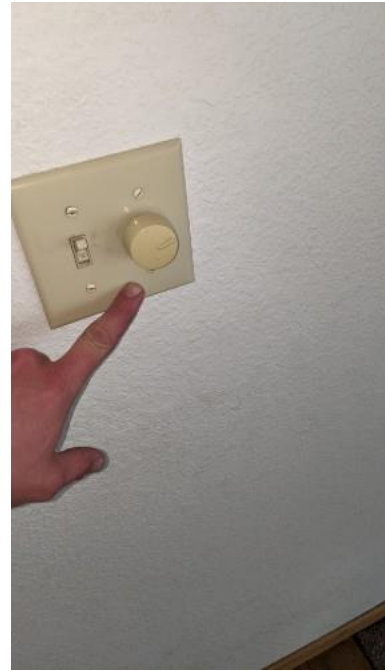
Control to ceiling lights on 2nd floor not working

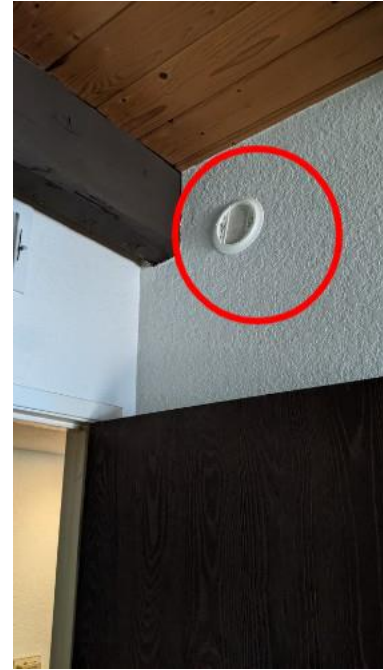
Southeast corner BR - no smoke detector
