# Inspection Report

## **ASAP Home Inspections LLC**

10555 Sample Drive Truckee, CA 96161

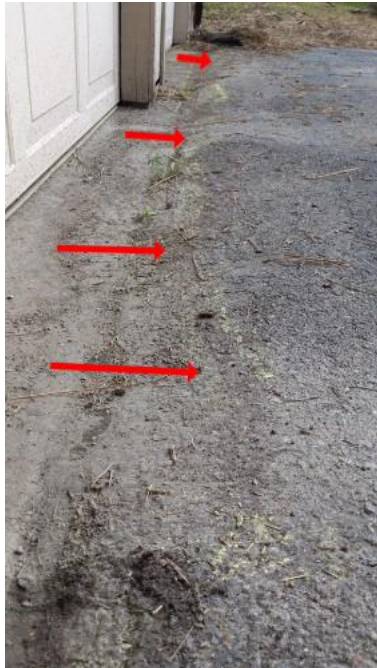
(Repair) Common cracks, major cracks and settlement were observed in the driveway making it an uneven surface. The major crack was 2" wide at the widest point. The driveway shows evidence of ponding. The driveway should be sloped to allow for proper drainage.

Bulge in the driveway by the garage

Recommend a qualified professional evaluate and repair or replace as needed.

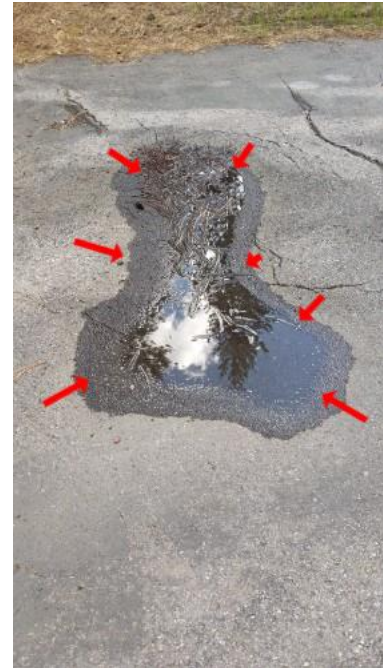
Ponding in driveway

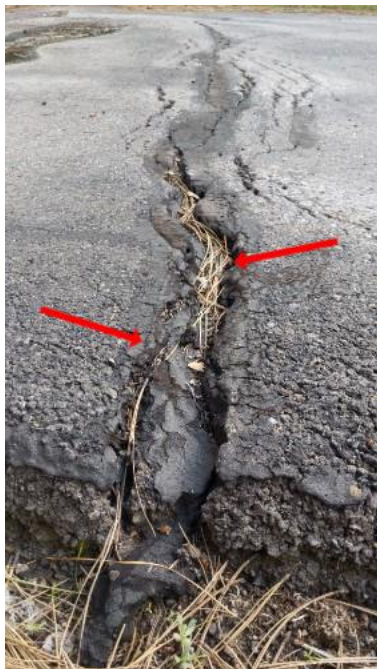
Large crack on side of driveway

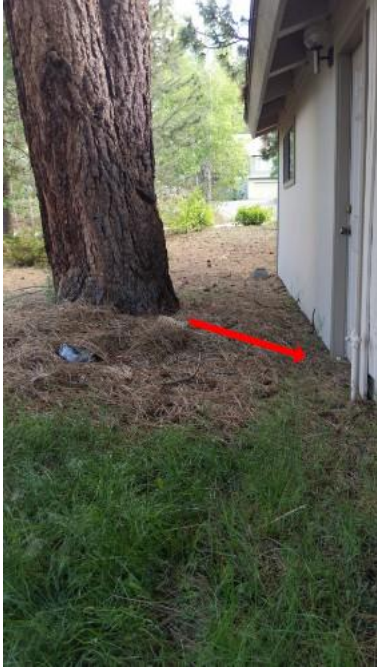
The grading slopes towards the South and East side of home/garage. The East side has a garage access door. This can allow water penetration. Recommend qualified professional evaluate and repair.

Slopes towards garage access door and East side of home.

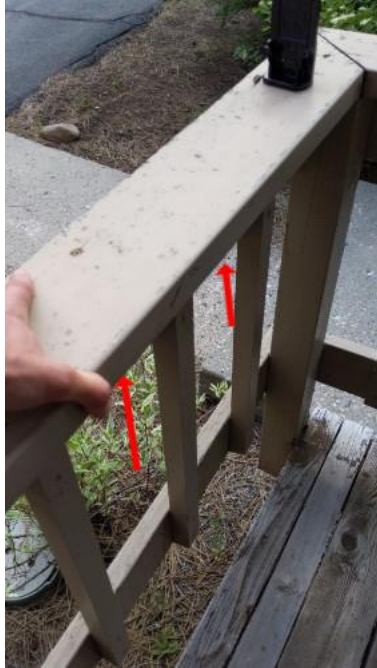
The top part of the railing is loose

It is suggested that a "Licensed General Contractor" be contacted for further evaluation and repair.

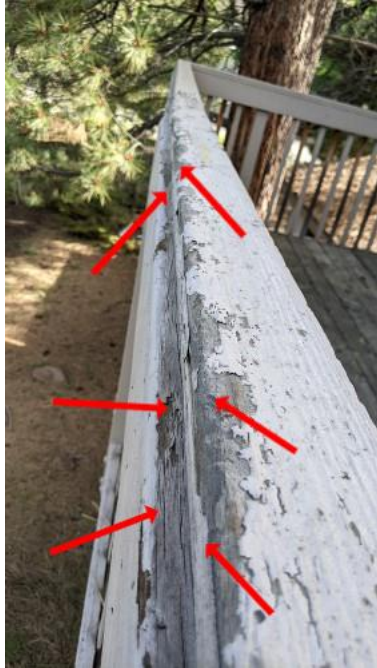
(Repair) The back deck railing had paint peeling and deterioration. The deck floor boards were weathered on top. Underneath the deck boards, multiple areas of paint peeling and deterioration were observed. Recommend qualified professionals re-paint and reseal these areas to prolong the life of the deck.

Paint peeling and deterioration on deck railing

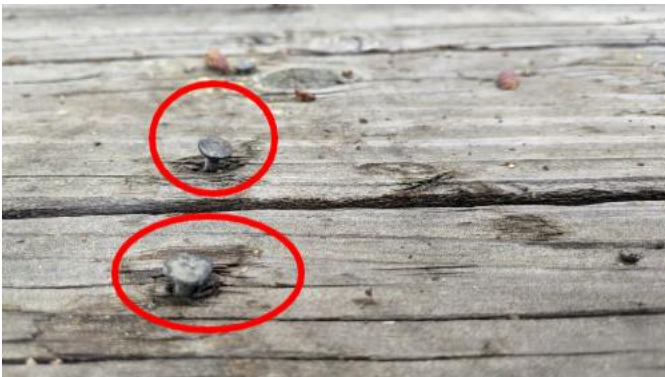
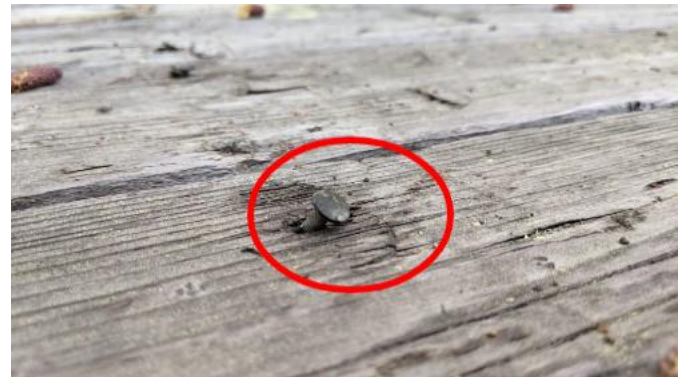
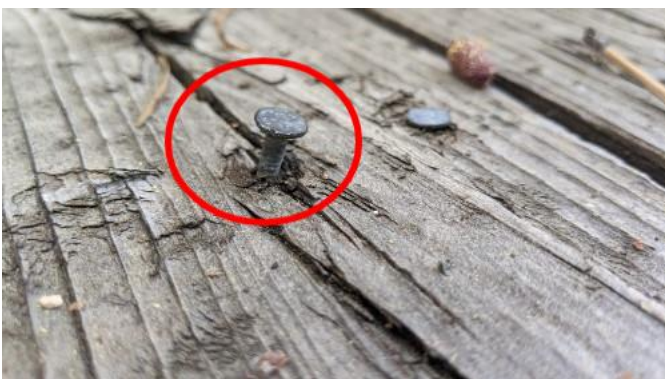
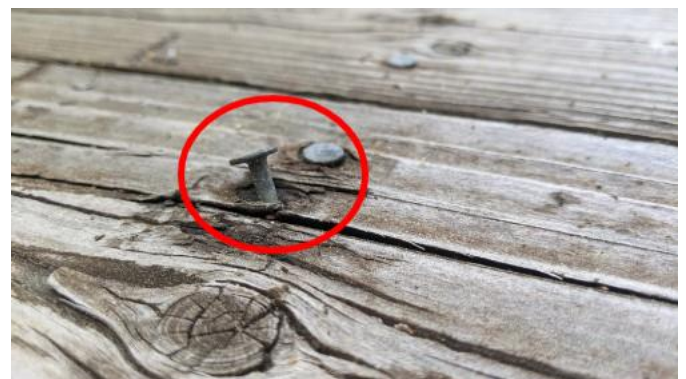
(Safety) The back deck railing (East) was loose at the time of inspection. This is a safety hazard. Multiple exposed nails raised above 1/4" were observed throughout the deck. These are a tripping hazard. It is suggested that a "Licensed General Contractor" be contacted for further evaluation and repair.

Exposed nails on deck floor surface

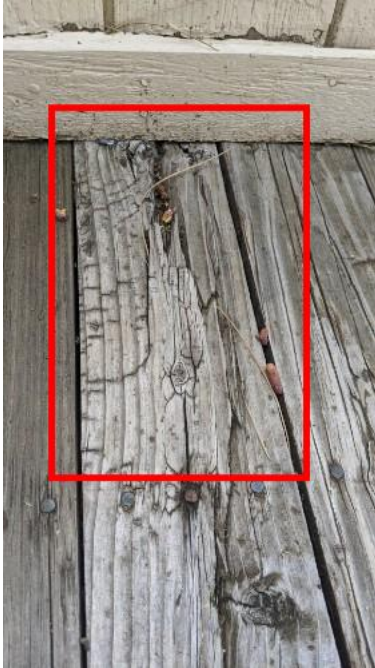
Weathered deck board cracking

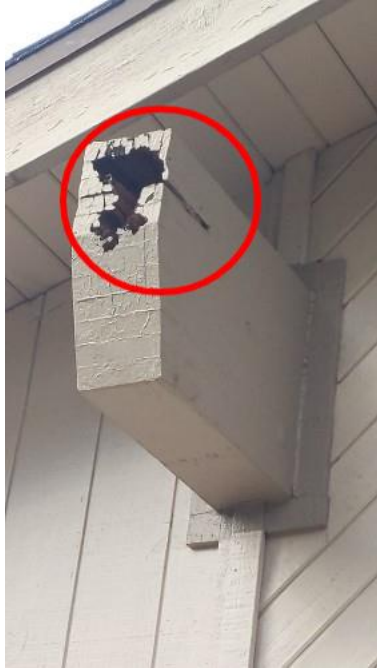
An exposed hole was observed on the East side of the home. This can allow moisture and pests to enter. Wood deterioration on the end of the wood beam on the South side of the home was observed. General paint chipping and deterioration was observed on the siding. It is suggested that a "Licensed General Contractor" be contacted for further evaluation and repair.

Wood beam deterioration

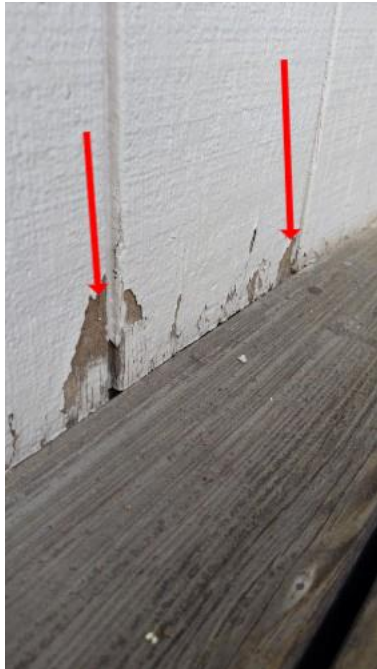
Paint peeling on siding

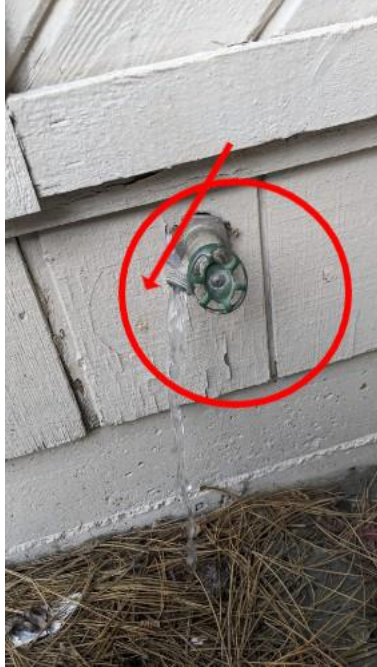
Two of the three outdoor faucets were not working at the time of the inspection. The one operable faucet was on the West side of the home closest to the garage. The operating faucet was not properly secured to the house. It is suggested that a "Licensed Plumbing Contractor" be contacted for further evaluation and repair.

This faucet was working but not properly attached

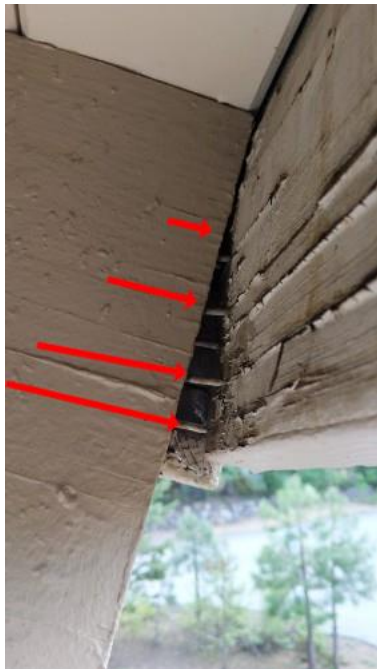
One of the fascias on the West side of home is bending away from the home and the nails are starting to pull away from the home. Other fascia paint deterioration was observed. It is suggested that a "Licensed General Contractor" be contacted for further evaluation and repair.

Fascia not secured

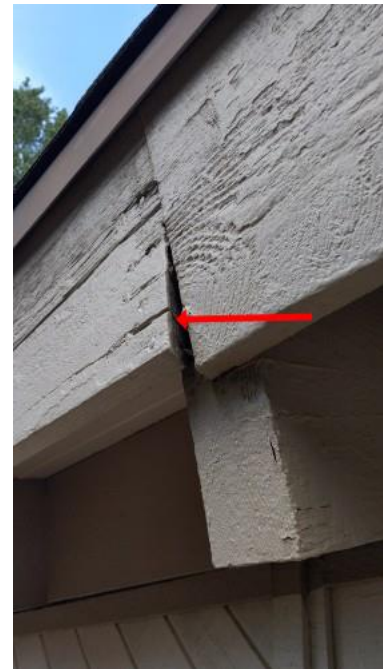
View of fascia not secure from other side

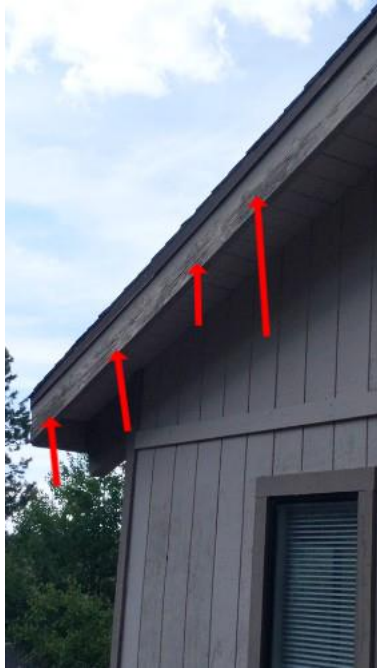
Fascia paint is deteriorating

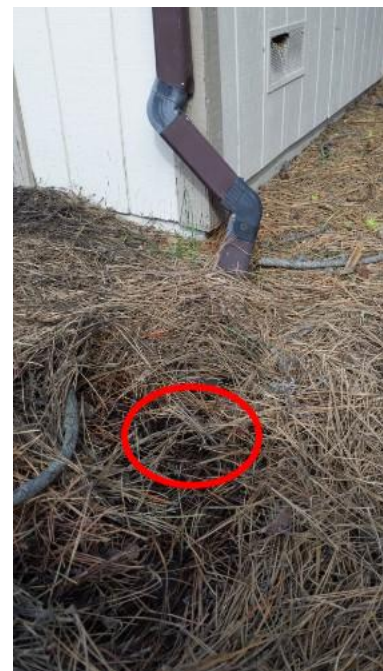
End of gutter is covered and is too close to house

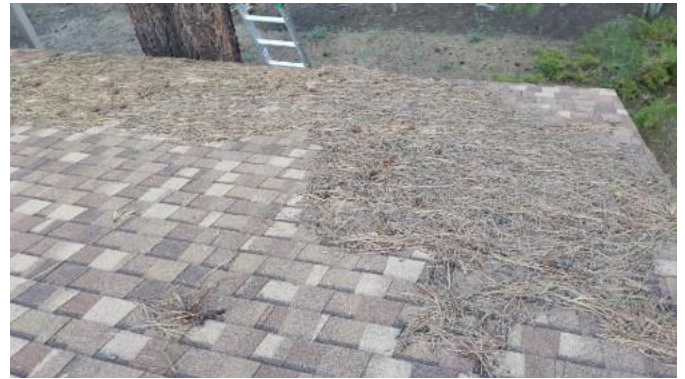
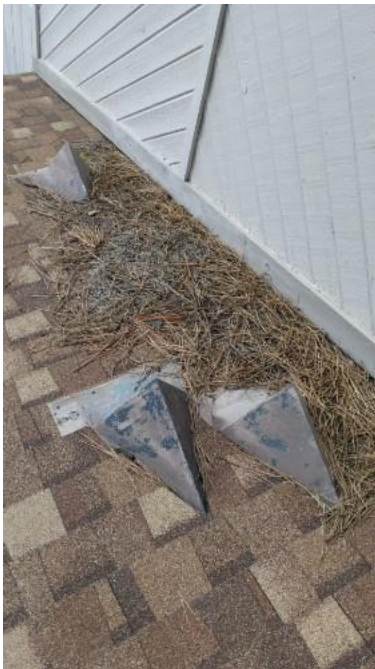
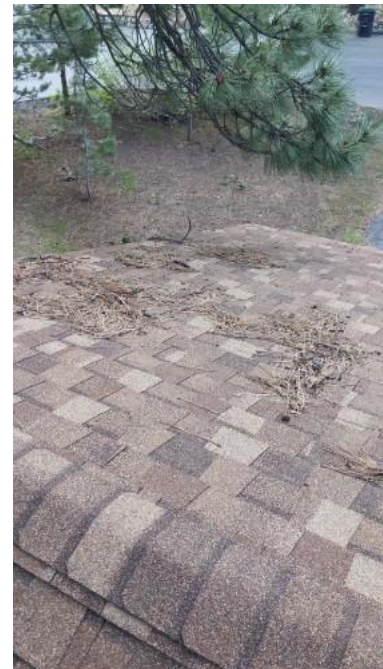
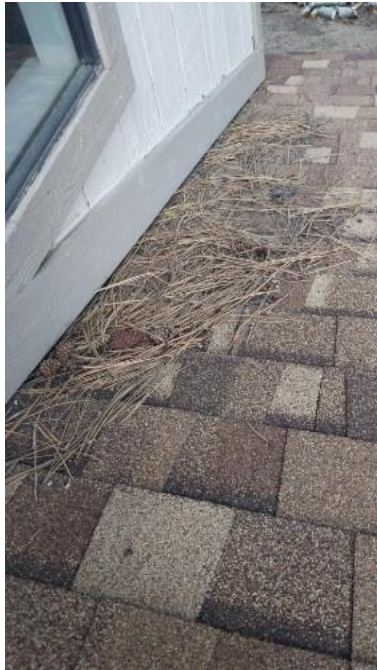
Tree overhangs the roof in an area(s). Falling debris and branches can damage the roof. Tree debris collected on the roof, this can allow organic growth and moisture intrusion. It is suggested that a "Licensed Landscaping Contractor" be contacted for further evaluation and repair.

Pine needles/debris on roof

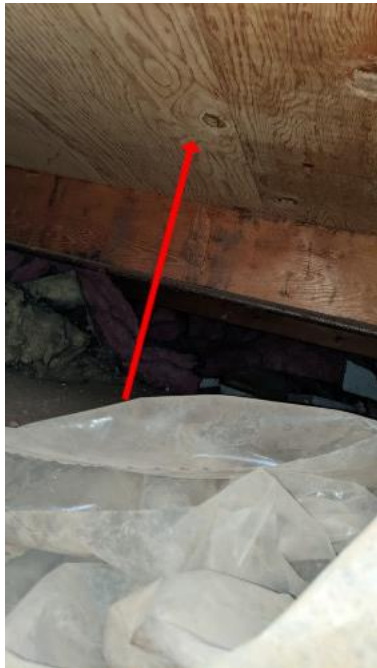
Falling and displaced insulation was observed. No insulation installed under flooring. Recommend qualified professionals correct and add insulation for energy efficiency.

No insulation under flooring

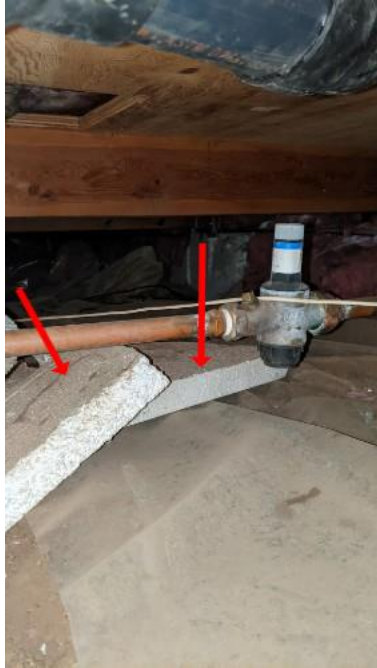
Falling foam board insulation

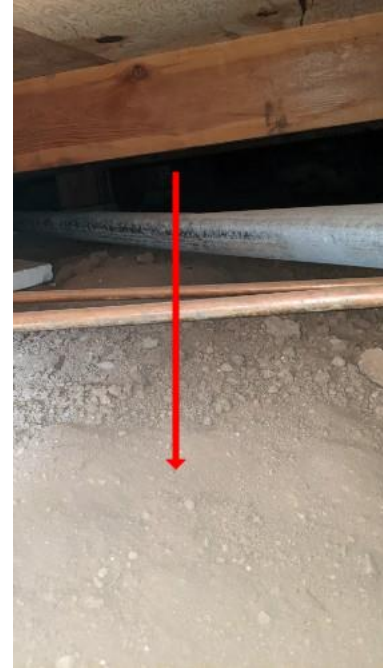
No vapor barrier installed. This can result in unwanted moisture. Crawlspace vents were covered shut at the time of inspection which does not allow airflow. Recommend a qualified professional install vapor barrier and evaluate ventilation.

Bare ground - no vapor barrier installed

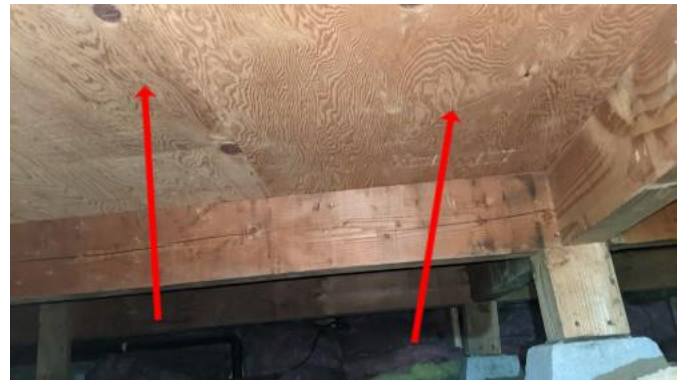
No insulation under flooring

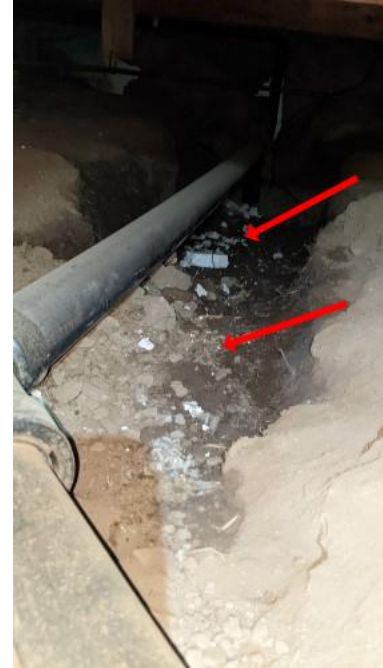
A damp/wet spot was observed under a drain pipe where the soil has fallen about 1 foot from the rest of the crawlspace. No active leak was observed. It is suggested that a "Licensed Plumbing Contractor" be contacted for further evaluation and repair.

Another view of wet/damp area under drain pipe

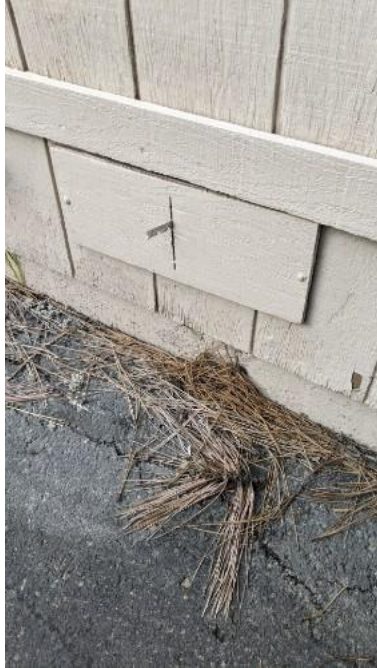
Crawlspace vents sealed up - no ventilation

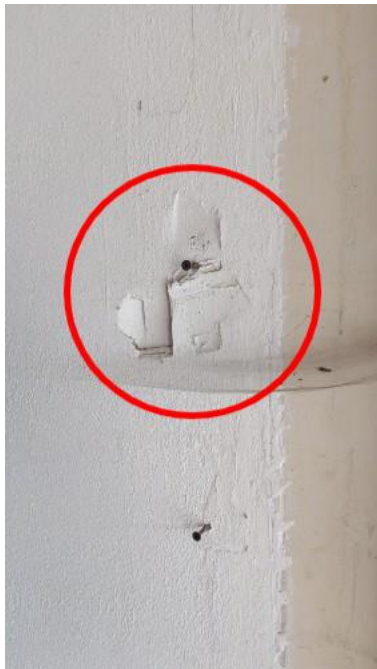
A puncture in the garage wall, uneven paint and general scuff marks were observed. It is suggested that a "Licensed General Contractor" be contacted for further evaluation and repair.

Puncture in the garage wall

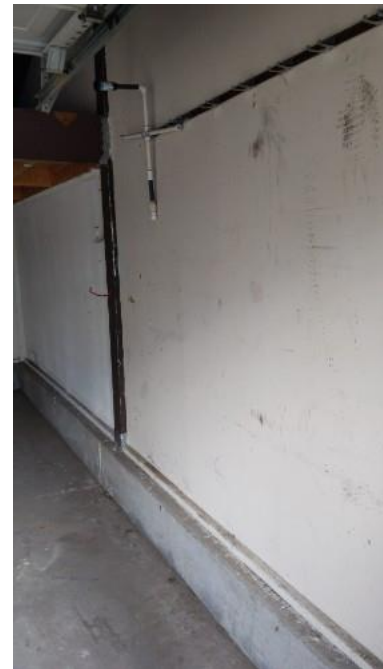
General scuff marks on garge wall

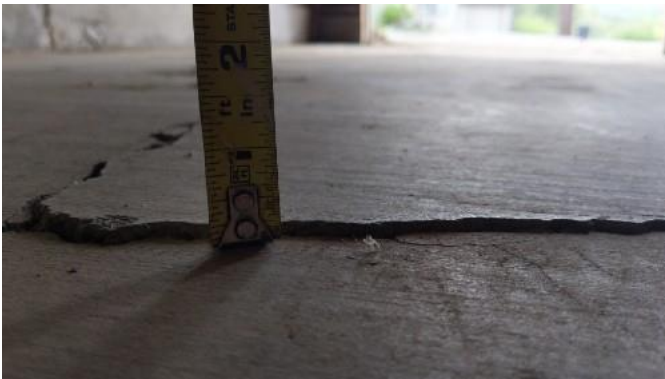
Multiple cracks and settlement were observed to the concrete flooring. Some cracks were raised 1/4" or more which is considered a trip safety hazard. Recommend further evaluation by a masonry contractor.

Settlement - near 1/4" height in crack

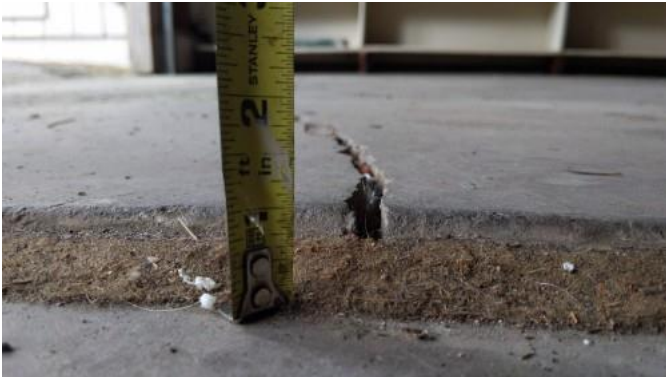
Middle divider of the two car garage is raised nearly an inch

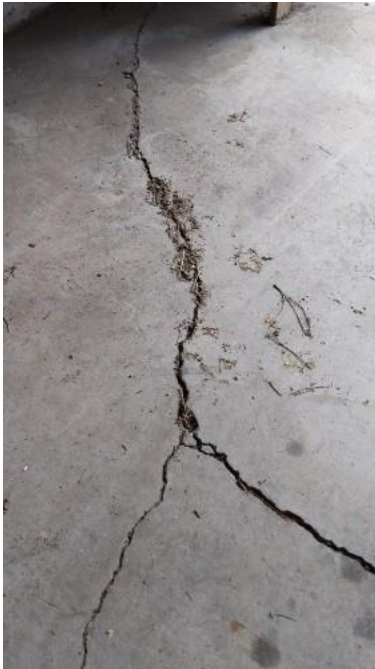
Crack in garage floor

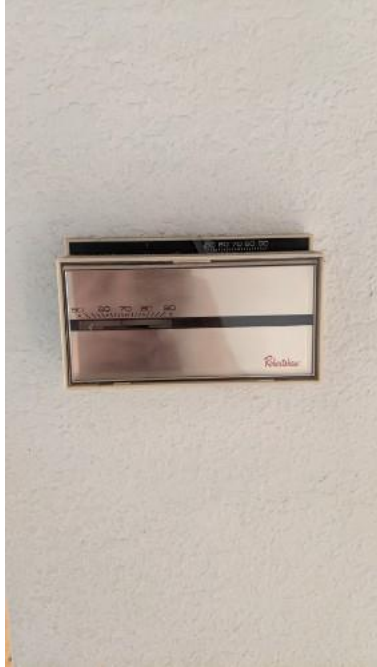
The thermostat on the first floor worked with normal operating procedures. The thermostat on the 2nd floor did not work with normal operation. It is suggested that a "Licensed Electrical Contractor" be contacted for further evaluation and repair.

2nd floor thermostat - not working

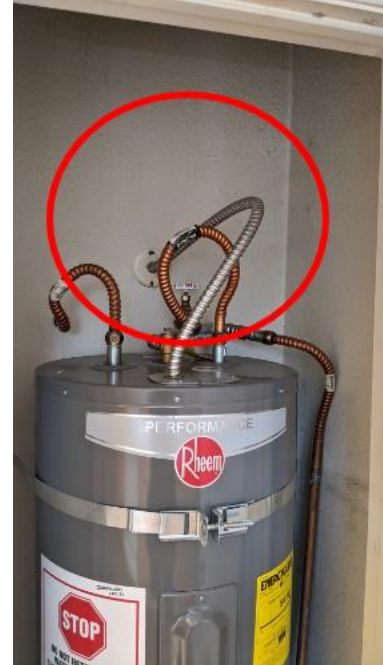
No expansion tank installed. The expansion tank equalizes pressure throughout the plumbing system by providing a space for hot water to flow into. Without an expansion tank, pressure would be distributed to the entire plumbing system, straining it and decreasing its lifespan. It is suggested that a "Licensed Plumbing Contractor" be contacted for further evaluation and installation.

No expansion tank

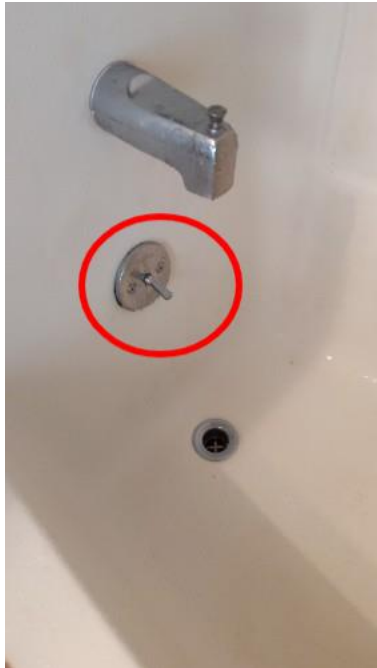
The bathroom drain stopper in the primary bedroom was inoperable. Shower diverter in the shared bathroom was not operating properly when engaged water was still running out of the bath faucet. It is suggested that a "Licensed Plumbing Contractor" be contacted for further evaluation and repair.

Drain stopper not operable

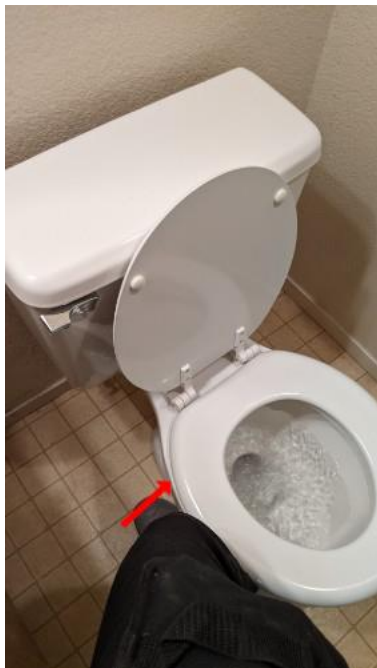
The toilet in the downstairs shared bathroom was loose at the time of inspection. It is suggested that a "Licensed Plumbing Contractor" be contacted for further evaluation and repair.

Toilet was loose

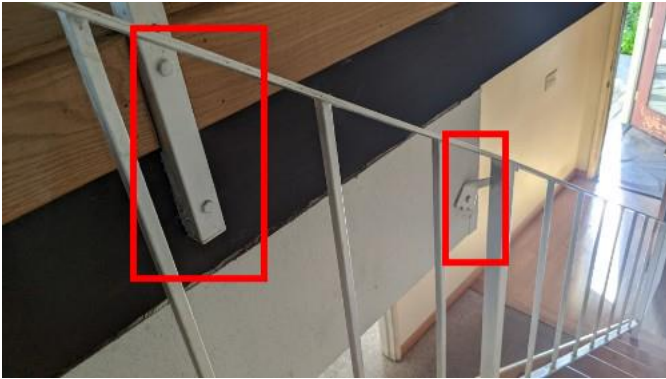
The stairway railing was loose at the time of inspection. It is suggested that a "Licensed General Contractor" be contacted for further evaluation and repair.

These bolts were loose

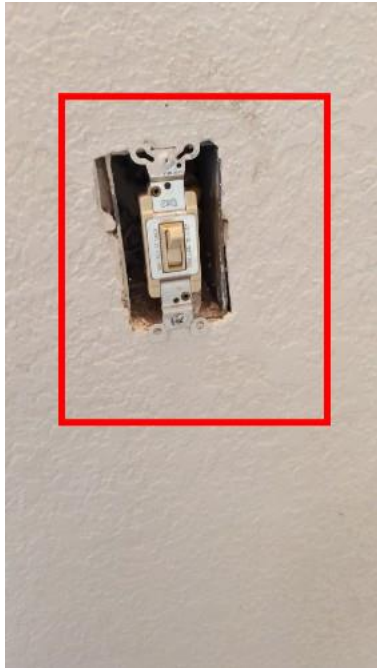
No cover plate - 1st floor by stairway

Damaged cover plates and outlets were observed throughout the home. A light control was missing a cover plate on the 1st floor. Bulbs were out in the downstairs bathroom and upstairs ceiling fan. No power to the upstairs ceiling lights. No power to the outlet by the wet bar and the outlets in the upstairs bathroom. It is suggested that a "Licensed Electrical Contractor" be contacted for further evaluation and repair.

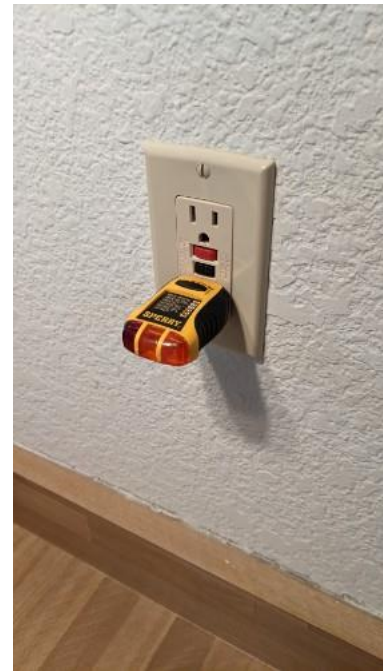
No power to outlet in upstairs bathroom

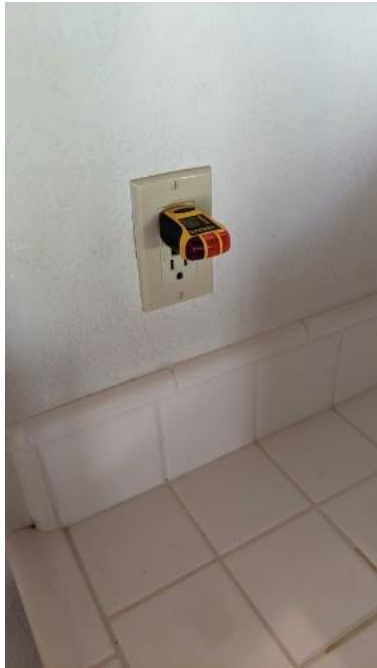
No power to this outlet by wet bar

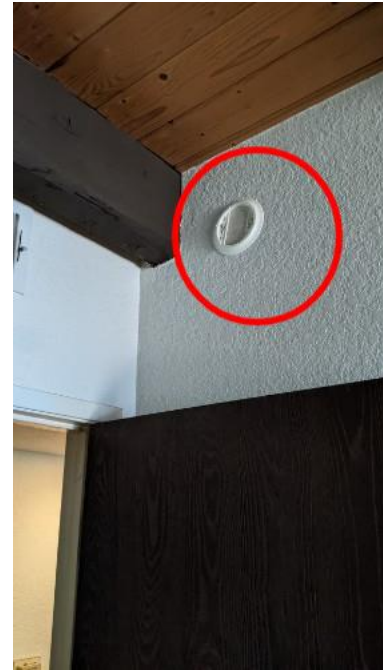
detector was missing or removed at the Southeast corner bedroom. Smoke detectors are required in all sleeping rooms. Recommend adding smoke detectors for safety.

Southeast corner BR - no smoke detector
