Inspection Report

ASAP Home Inspections LLC

10555 Sample Drive Truckee, CA 96161

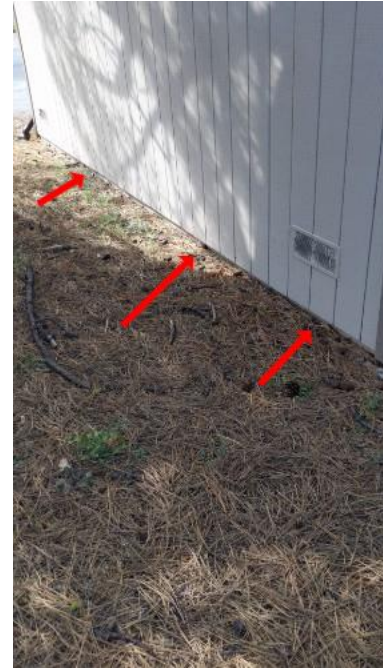
The grading slopes towards the South and East side of home/garage. The East side has a garage access door. This can allow water penetration. Recommend qualified professional evaluate and repair.

6-8" of ground clearance recommended. Earth/soil is in contact with wood siding which allows deterioration and moisture penetration. Recommend the wood siding be at least 6" from Earth/soil/ground.

South Side of home

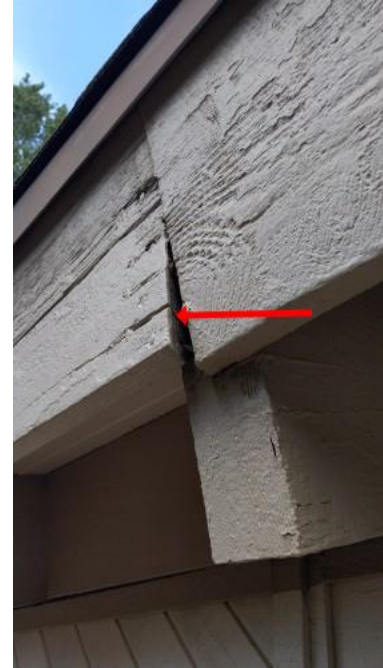
One of the fascias on the West side of home is bending away from the home and the nails are starting to pull away from the home. Other fascia paint deterioration was observed. It is suggested that a "Licensed General Contractor" be contacted for further evaluation and repair.

View of fascia not secure from other side

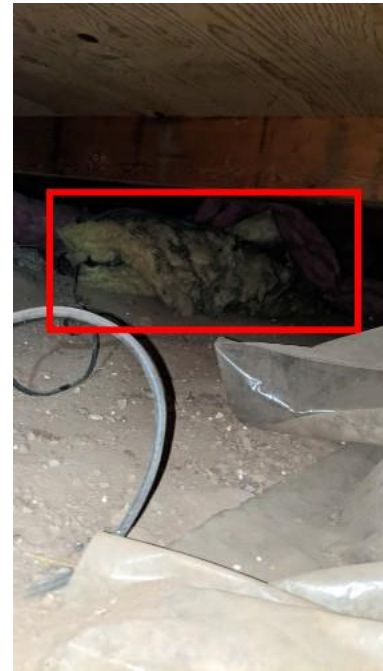
Falling and displaced insulation was observed. No insulation installed under flooring. Recommend qualified professionals correct and add insulation for energy efficiency.

Displaced insulation

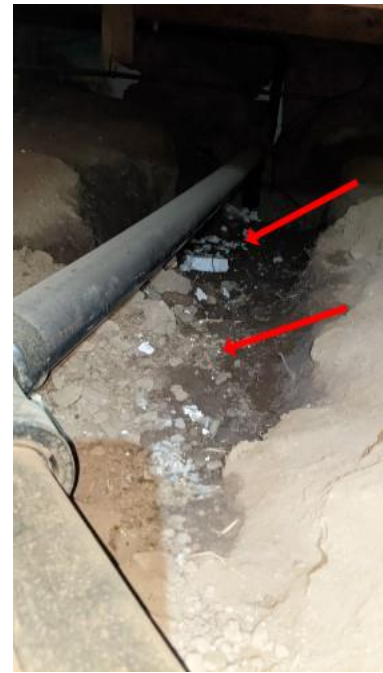
A damp/wet spot was observed under a drain pipe where the soil has fallen about 1 foot from the rest of the crawlspace. No active leak was observed. It is suggested that a "Licensed Plumbing Contractor" be contacted for further evaluation and repair.

Another view of wet/damp area under drain pipe

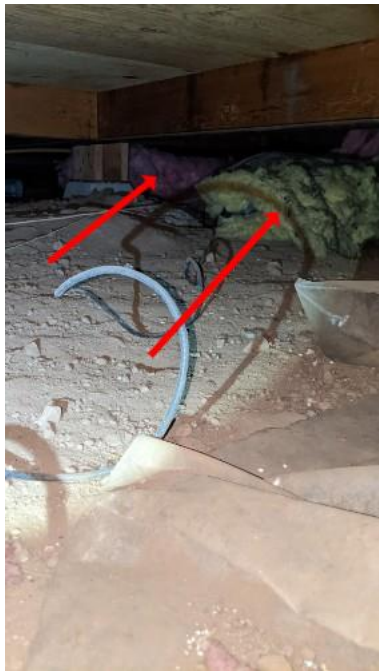
Displaced insulation

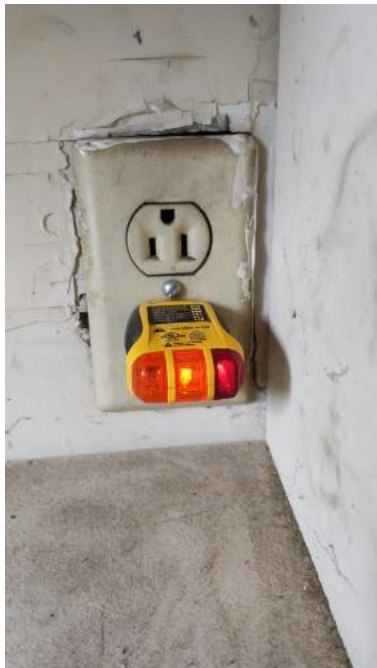
Hot/neutral reversed

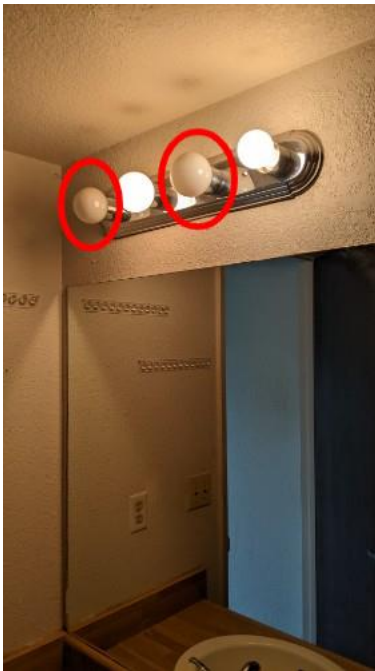
Damaged cover plates and outlets were observed throughout the home. A light control was missing a cover plate on the 1st floor. Bulbs were out in the downstairs bathroom and upstairs ceiling fan. No power to the upstairs ceiling lights. No power to the outlet by the wet bar and the outlets in the upstairs bathroom. It is suggested that a "Licensed Electrical Contractor" be contacted for further evaluation and repair.

Bathroom bulbs out

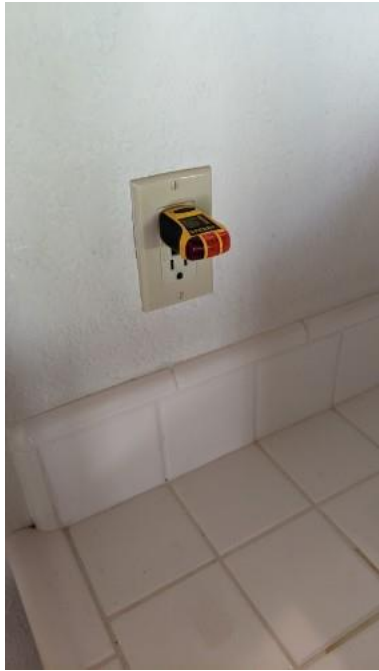
No power to this outlet by wet bar
