# Inspection Report

## **ASAP Home Inspections LLC**

10555 Sample Drive Truckee, CA 96161

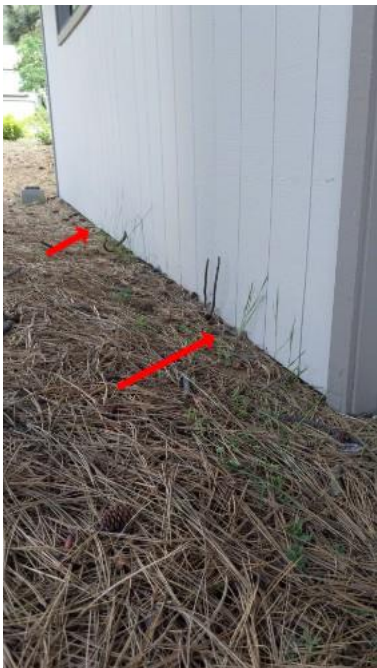
East side of home

6-8" of ground clearance recommended. Earth/soil is in contact with wood siding which allows deterioration and moisture penetration. Recommend the wood siding be at least 6" from Earth/soil/ground.

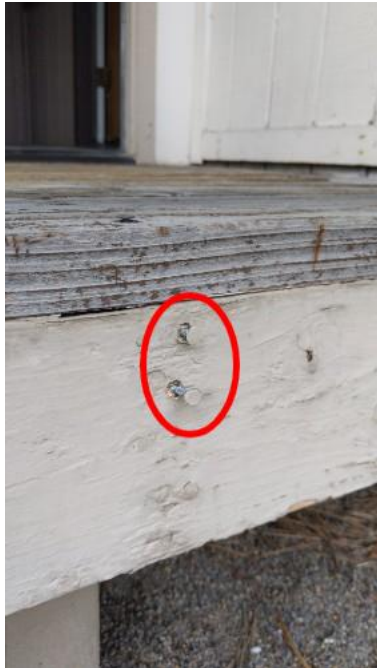
Nails exposed

It is suggested that a "Licensed General Contractor" be contacted for further evaluation and repair.

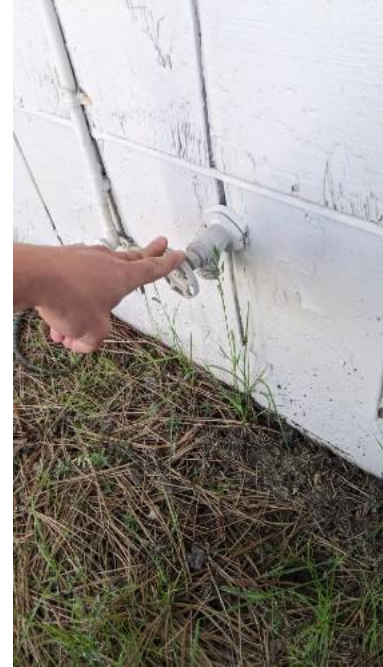
Two of the three outdoor faucets were not working at the time of the inspection. The one operable faucet was on the West side of the home closest to the garage. The operating faucet was not properly secured to the house. It is suggested that a "Licensed Plumbing Contractor" be contacted for further evaluation and repair.

Faucet on back of home (East) not working

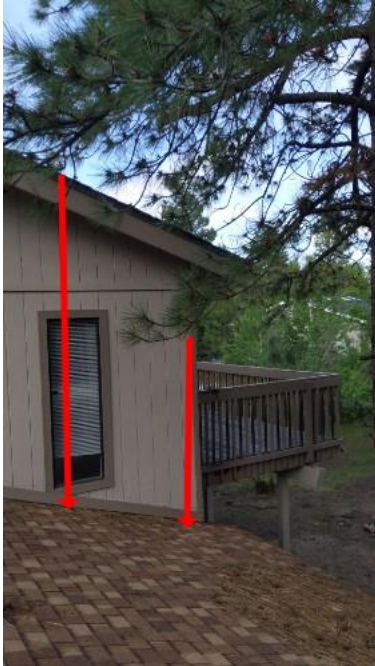
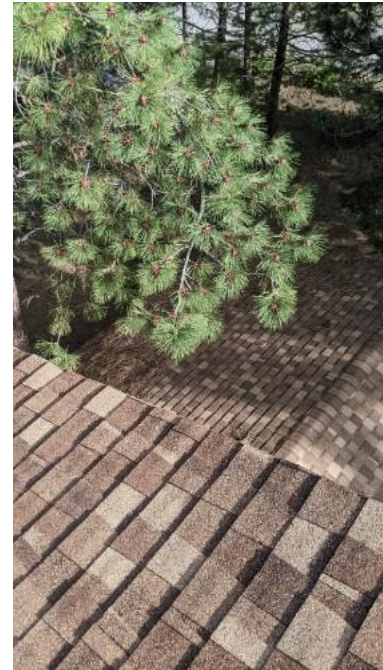
Tree overhangs the roof in an area(s). Falling debris and branches can damage the roof. Tree debris collected on the roof, this can allow organic growth and moisture intrusion. It is suggested that a "Licensed Landscaping Contractor" be contacted for further evaluation and repair.

Tree overhangs roof

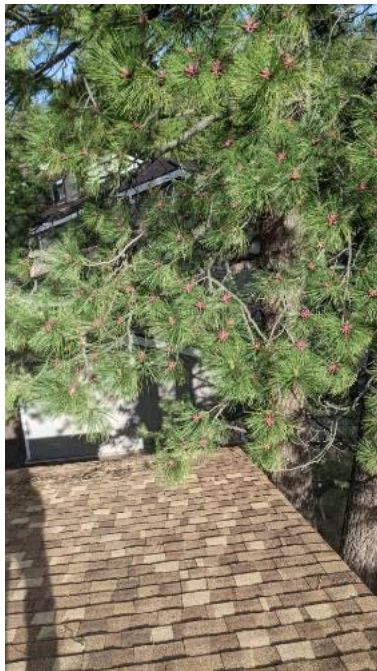
Tree overhangs roof

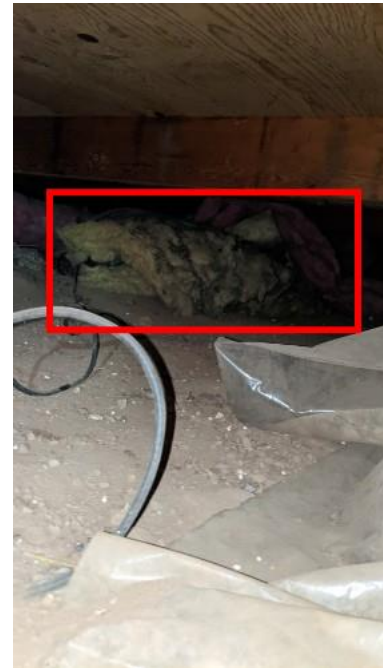
Falling and displaced insulation was observed. No insulation installed under flooring. Recommend qualified professionals correct and add insulation for energy efficiency.

Displaced insulation

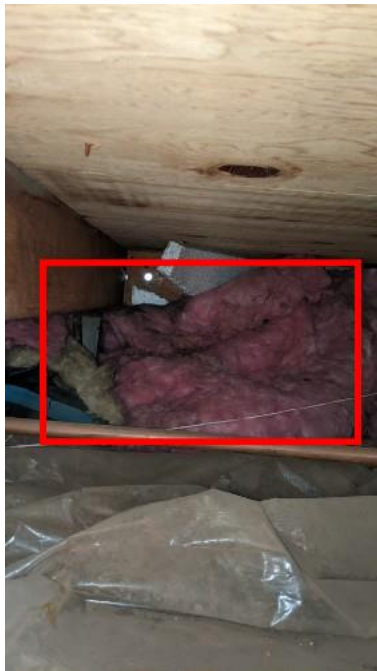
Displaced insulation

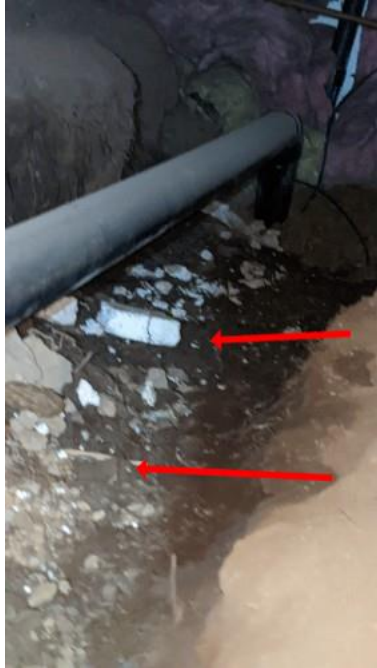
A damp/wet spot was observed under a drain pipe where the soil has fallen about 1 foot from the rest of the crawlspace. No active leak was observed. It is suggested that a "Licensed Plumbing Contractor" be contacted for further evaluation and repair.

Wet/damp area under drain pipe and soil is lower

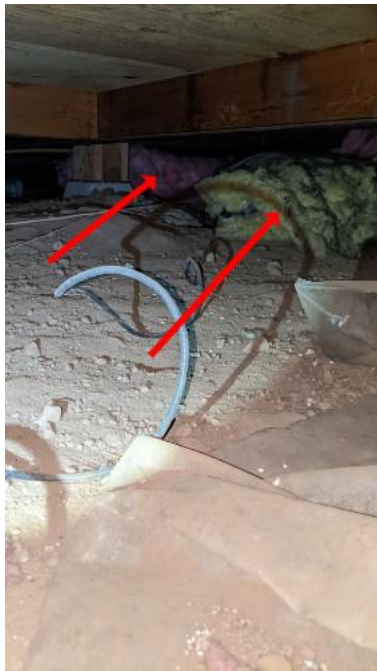
Displaced insulation

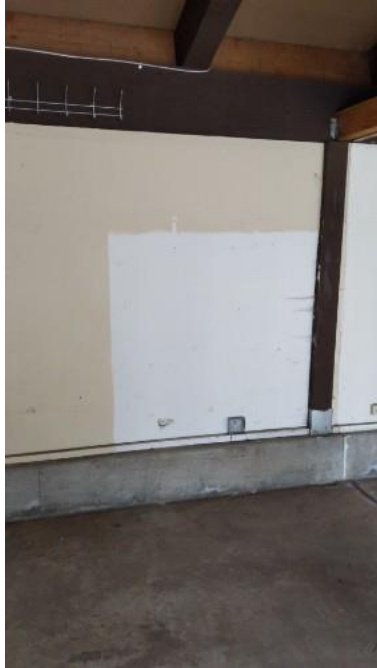
Uneven paint

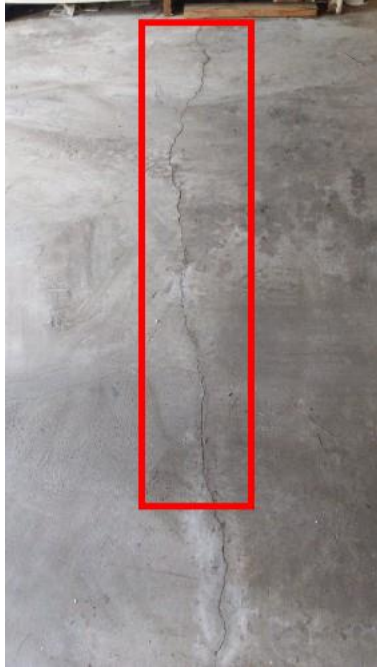
Multiple cracks and settlement were observed to the concrete flooring. Some cracks were raised 1/4" or more which is considered a trip safety hazard. Recommend further evaluation by a masonry contractor.

Hairline crack

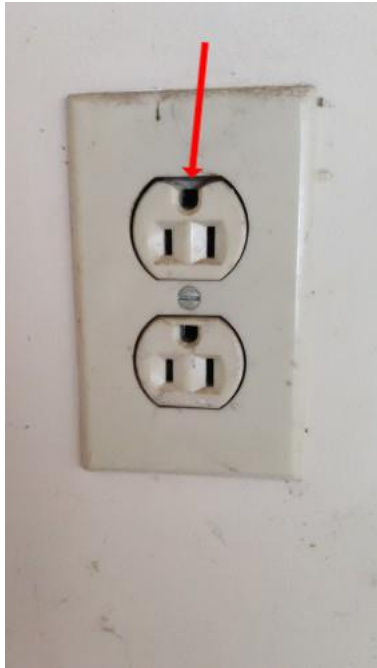
A damaged outlet, a missing cover plate, and an incorrect cover plate was observed in the garage. Hot/neutral was reversed on one outlet. It is suggested that a "Licensed Electrical Contractor" be contacted for further evaluation and repair.

Damaged outlet

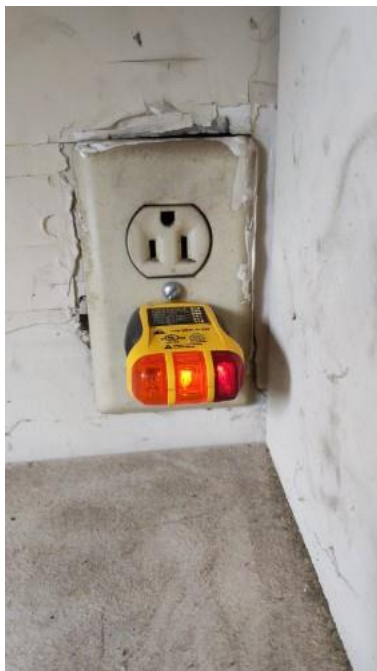
Hot/neutral reversed

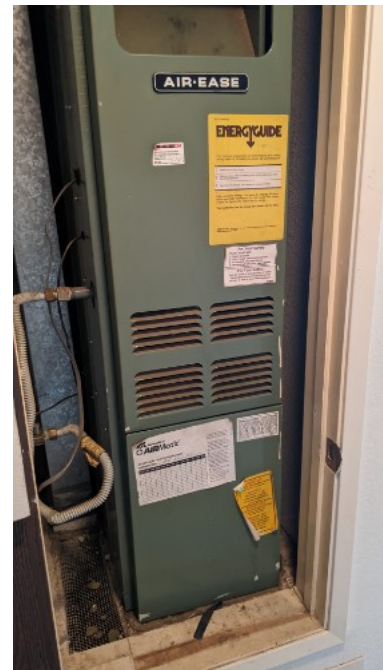
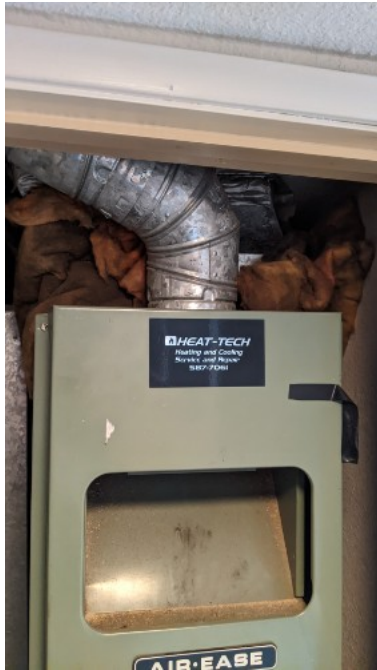
The heating system was operational at time of inspection. This is not an indication of future operation or condition. The system is older and appears to be past its normal life expectancy. Client should consider replacement with a modern unit conforming to modern safety standards and efficiencies.

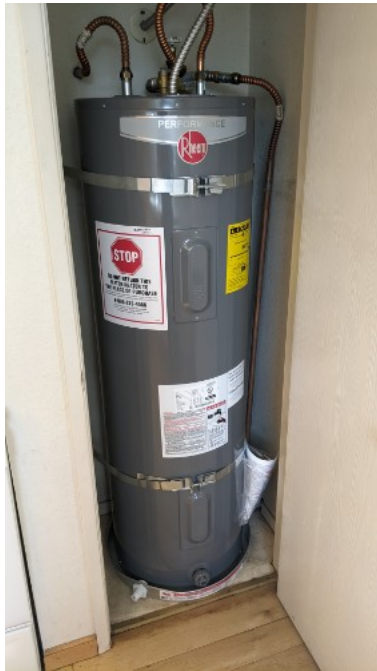
No expansion tank installed. The expansion tank equalizes pressure throughout the plumbing system by providing a space for hot water to flow into. Without an expansion tank, pressure would be distributed to the entire plumbing system, straining it and decreasing its lifespan. It is suggested that a "Licensed Plumbing Contractor" be contacted for further evaluation and installation.

No expansion tank

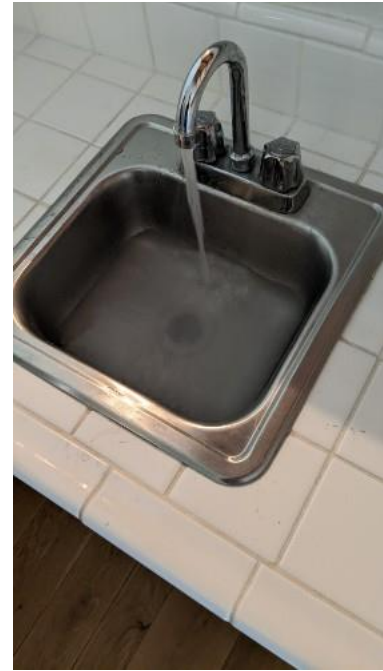
changing the aerator. Wet bar sink was draining slowly. It is suggested that a "Licensed Plumbing Contractor" be contacted for further evaluation and repair.

Slow drain

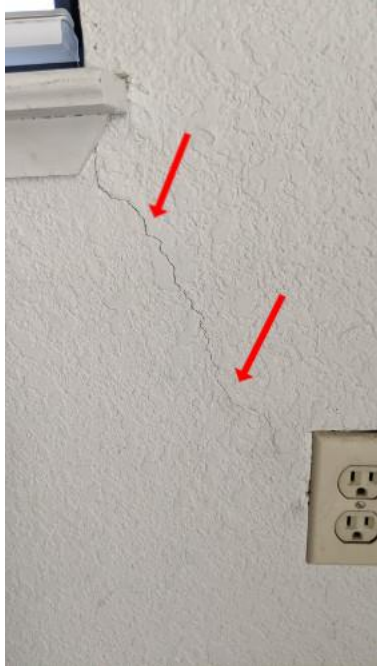
Minor settlement cracks were observed on the upstairs East wall. Recommend monitoring these cracks and sealing.

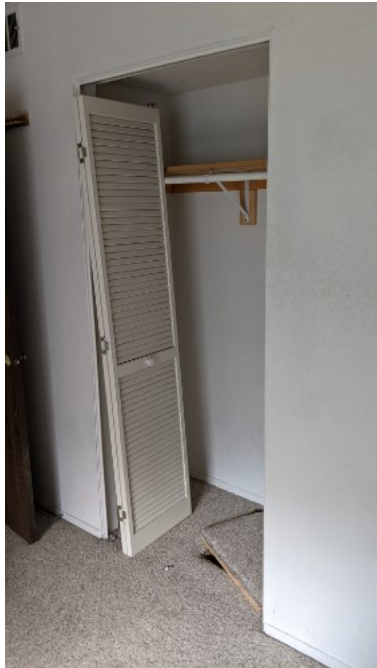
The closet door in the primary bedroom was not operable at the time of inspection. It is suggested that a "Licensed General Contractor" be contacted for further evaluation and repair.

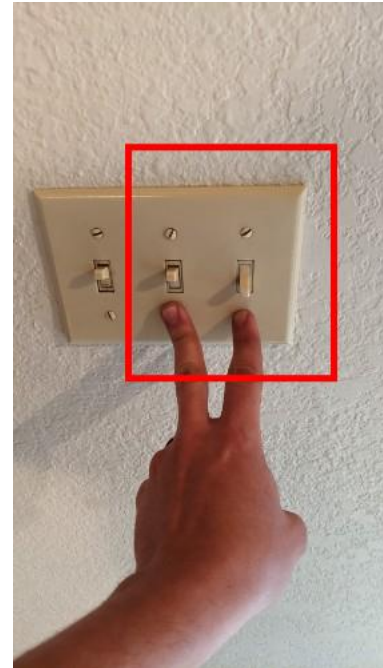
These two switches by front door did not operate

Damaged cover plates and outlets were observed throughout the home. A light control was missing a cover plate on the 1st floor. Bulbs were out in the downstairs bathroom and upstairs ceiling fan. No power to the upstairs ceiling lights. No power to the outlet by the wet bar and the outlets in the upstairs bathroom. It is suggested that a "Licensed Electrical Contractor" be contacted for further evaluation and repair.

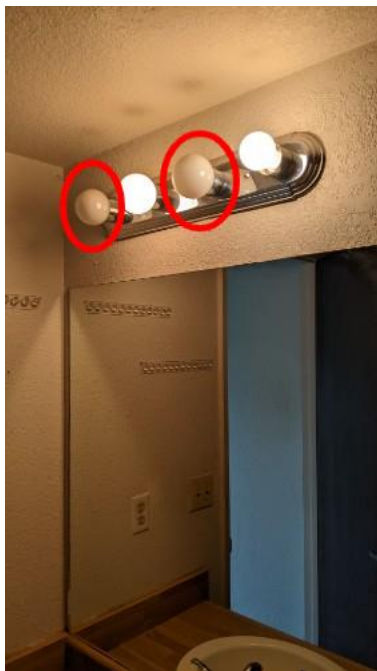
Bathroom bulbs out

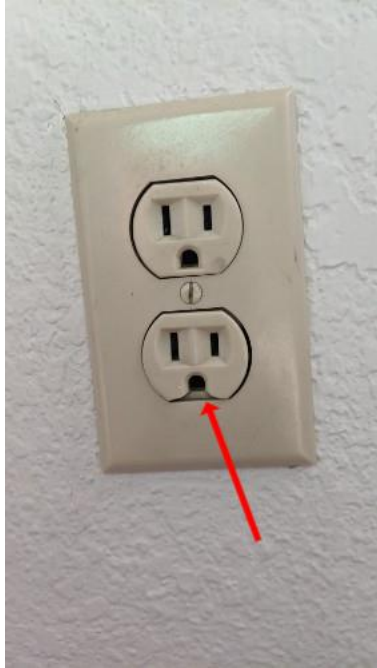
Damaged outlet

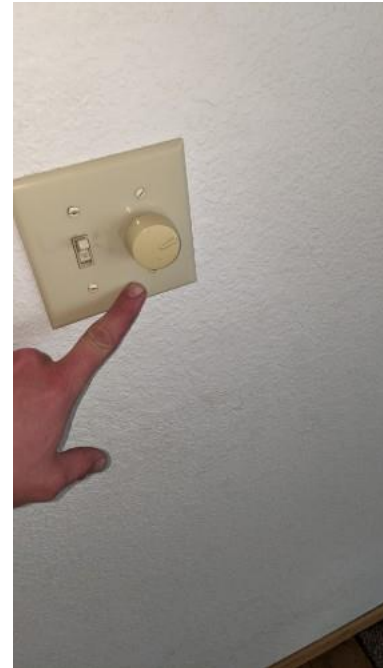
Control to ceiling lights on 2nd floor not working

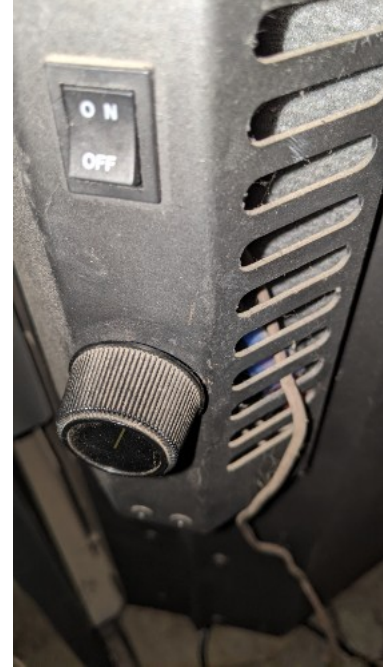
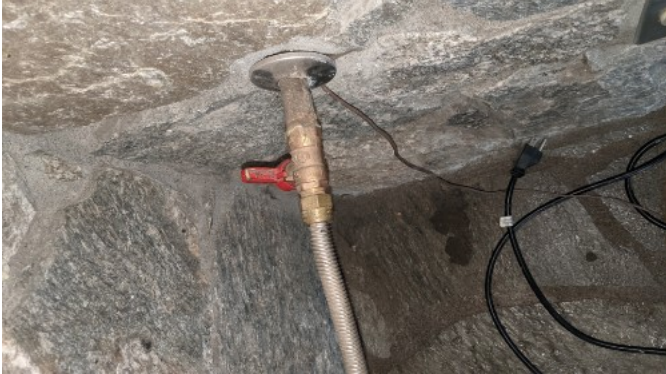
The gas fireplace pilot was not lit or fuel / gas was turned off. The gas fireplace could not be fully inspected. Lighting of pilots or adjustments of automatic ignition systems is not performed as part of this inspection. Client is advised to obtain information from the manufacturer regarding use, maintenance, and carbon monoxide risks, if any.
